ASSESSMENT AND REPAIR OF RC STRUCTURE DAMAGED IN A FIRE - CASE STUDY

Abstract: The load-bearing reinforced concrete structure of the last six floors was severely damaged in the fire that occurred on the 12th floor of the 54 m tall building in Novi Sad in April 2000. This paper gives a short description of the damages to the basic structural elements and an assessment of the condition of the load-bearing structure from the 8th to the 13th floors and offers a conclusion concerning the adequate repair measures needed to obtain the load-bearing capacity and stability of the building. It also presents the details of the repair of the basic load-bearing elements of the RC structure and the rehabilitation and strengthening measures.

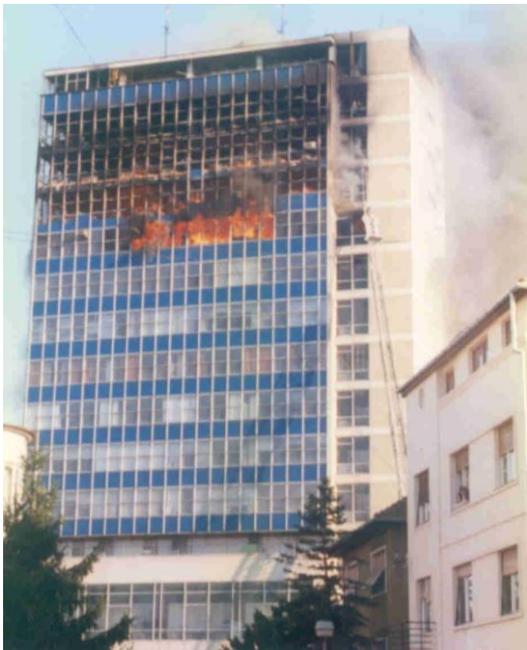
In April 2000, a fire spread in the building of the Novi Sad Open University (Fig. 1 and 2). It broke out on the 12th floor and rapidly spread over the last six floors of the building. Due to the fire, which lasted for approximately six hours and was mainly extinguished with water, the load-bearing structure of the building was damaged and the facade, the interior and the installations were completely destroyed on floors caught by fire.

Figure 1. The 9th floor in fire

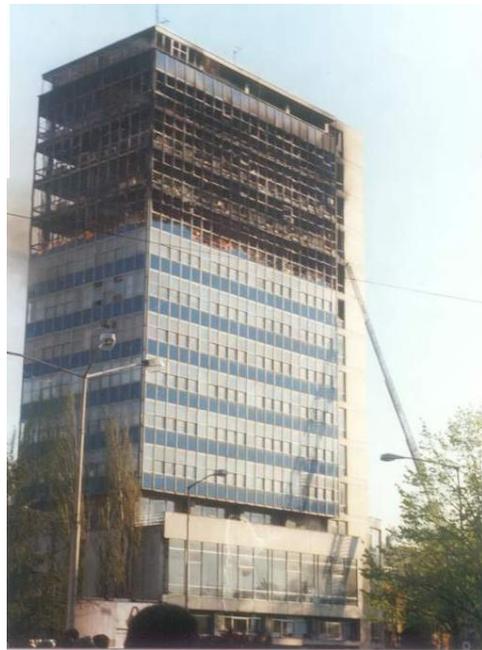
Figure 2. The view of the building after fire

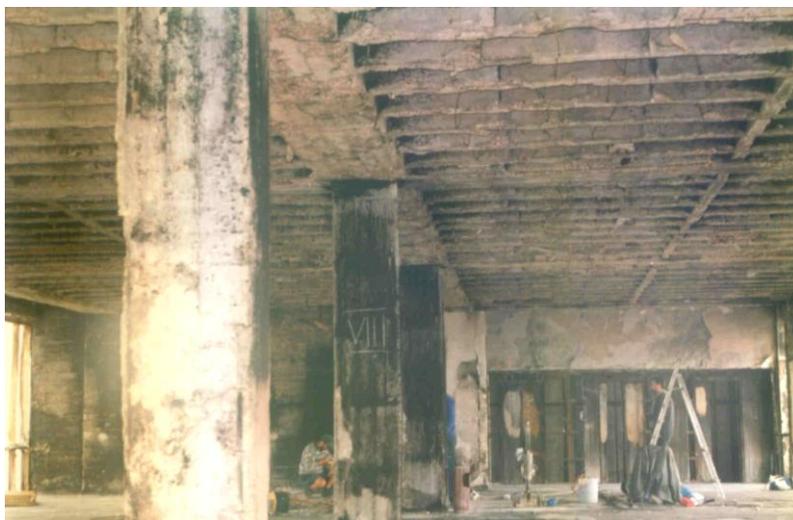
Figure 5. The view of the damaged structure on the 8th floor after the fire and clearing

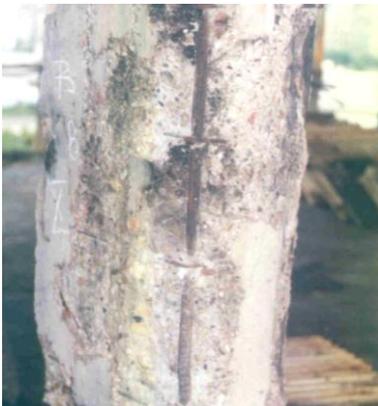
- All reinforced concrete columns were damaged in the fire (characteristic view in Fig. 6). The concrete cover, approx. 4 cm thick, is crumbled, dilapidated and cracked. In the interior of concrete, at the depth up to 12 cm, there are cracks which point to the separation of the outer layer from the sound core of concrete. The edges of columns are separated or fallen off up to longitudinal reinforcement. Bond between concrete and reinforcement has been impaired.

Figure 6. Typical view of the column after fire

- The removal of damaged, dilapidated and cracked parts of concrete up to the sound concrete and uncovering the main reinforcement (Fig. 10, 11),

- The placing of additional vertical reinforcement bars $\varnothing 14\text{mm}$ and stirrups $\varnothing 8\text{mm}/10\text{cm}$ (Fig. 12 and 13),
- Connecting the new bars with existing reinforcement by direct welding and additional steel plates (Fig. 12),
- Coating of the surface of the existing concrete and reinforcement of columns with the material for improving the bond between old and new concrete,
- Applying a new concrete cover with polymer modified concrete of class C40/50 in two phases through holes in the formwork from the upper slab (Fig. 14, 15 and 16).

By this method of rehabilitation and strengthening of damaged columns, existing cross-section dimensions were increased by 10cm.

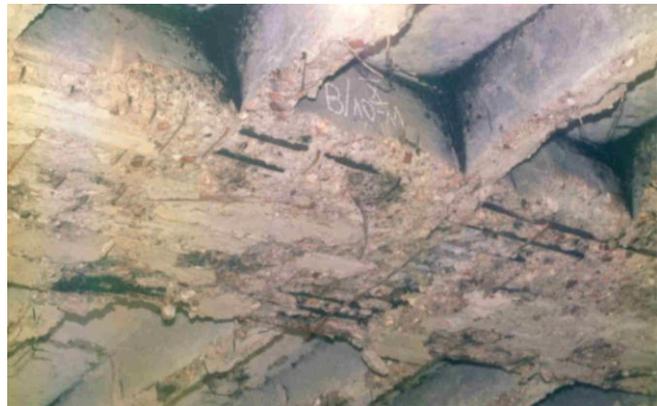
- All longitudinal and transversal reinforced concrete beams were damaged due to the fire (characteristic view in Fig. 7). The surface concrete layer from the lower side was dilapidated and broken off (thickness of this layer was approx. 5cm). The edges were cracked or broken off along the whole height, and longitudinal

reinforcement was bared. There are vertical cracks on the sides of approx. 0.5 mm of width, and horizontal cracks at the joints of transversal beams and slab. Adhesion between concrete and rebars in the lower zone has been impaired.

Figure 7. The characteristic view of the longitudinal beam after fire

Since the damages of the RC beams due to the fire occurred only in the concrete cover, the reinforcement was not been damaged, these elements were repaired by replacing the damaged concrete cover.

- The removal of damaged, dilapidated and cracked concrete cover from bottom and side surfaces (up to the sound concrete and partial uncovering the main longitudinal reinforcement and stirrups (Fig. 17 and 18),
- placing of the new cover by pouring self-leveling repair mortar through hollows in the slab (Fig. 19 and 20),
- The upper part on the side surfaces of these beams was repaired by a manual application of polymer modified cement mortar (Fig.21).

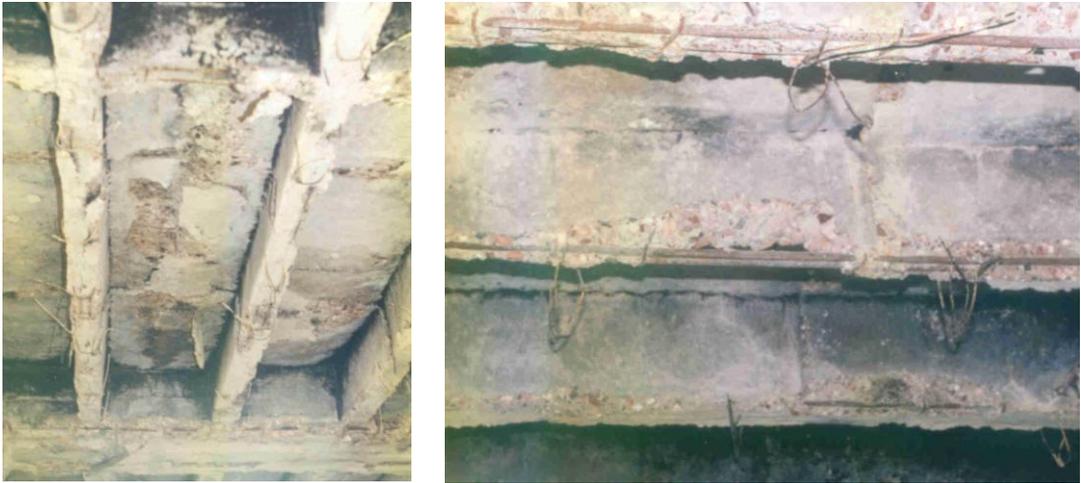
- The pan-joint structure was the most severely damaged element of the load-bearing structure due to its small dimensions and unfavorable position in relation to the fire (characteristic view in Fig. 8 and 9). The lower parts of ribs up to 15 cm in height were broken off, while the remaining parts were cracked and dilapidated. The reinforcement was bared along the whole length of the ribs, and adhesion between it and concrete was impaired. There were slanting or vertical cracks at the points of swaying of reinforcement bars from the lower into the upper zone and horizontal cracks at the joint with the plate. The slab was 5 cm thick and had net-like cracks on the lower side. The 3 cm thick cover was dilapidated, crumbled and fallen off, especially at places of uneven changes in dimensions and breaks of concreting, where the damage affects the slab in its whole thickness.

Figure 8 and 9. The characteristic view of the pan-joint structure after fire

RC pan-joint structure was the most damaged element of the structure. The required repair and reinforcement of the plate floor structure with the preservation of the same construction system would demand hiring a large number of construction workers who would have to repair manually almost all the ribs and most of the slab. Therefore, the repair measures where the existing floor structure is substituted without removing it, i.e., the building of new RC beams along the 1/3 of the span and a 6cm tick slab over the existing one (Fig. 22) was chosen as a solution. Figures 23 and 24 show the transversal and typical cross-sections of the new beams with the arrangement of the reinforcement.

- The removal of damaged, dilapidated and cracked parts of concrete from the ribs and the bottom surface of the slab and removal of screed;
- Supporting of the existing pan-joint structure ribs;
- Removal of parts of the slab for the execution new RC beams (Fig. 25 and 26);

- installing of new beam reinforcement by anchoring in the existing longitudinal beams and placing the mesh reinforcement for the new slab (Fig. 27);
- Concreting of the new beams and the slab with concrete of class C30/37 (Fig 28.)

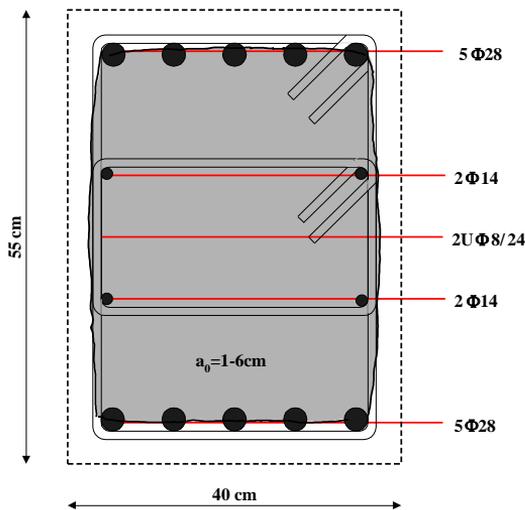
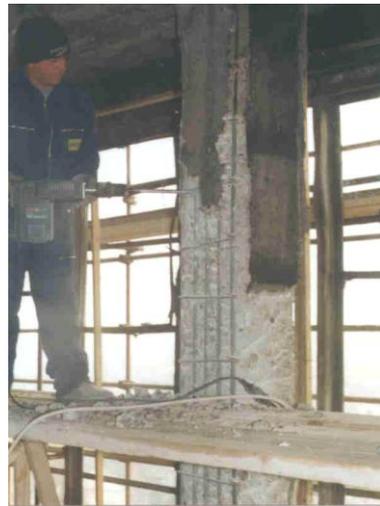
Figure 10 and 11. Removal of the damaged concrete layer from the column

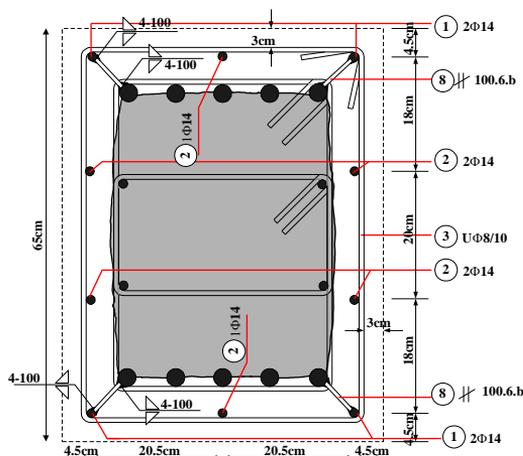
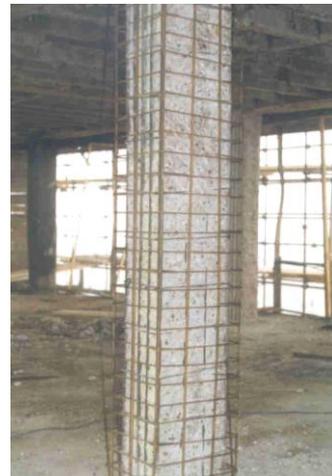
Figure 12. The placing of the new column reinforcement

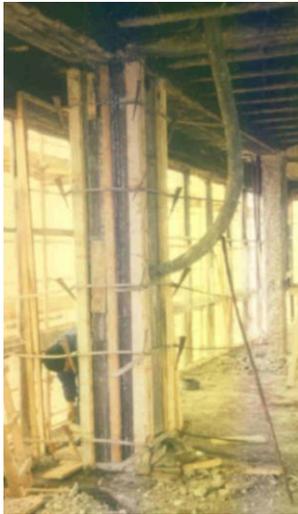
Fig 14. Placing of the new layer on the column

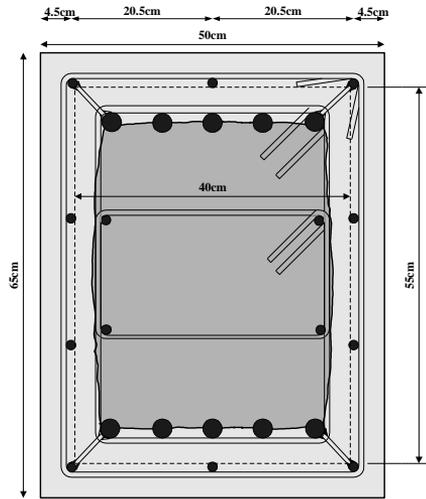
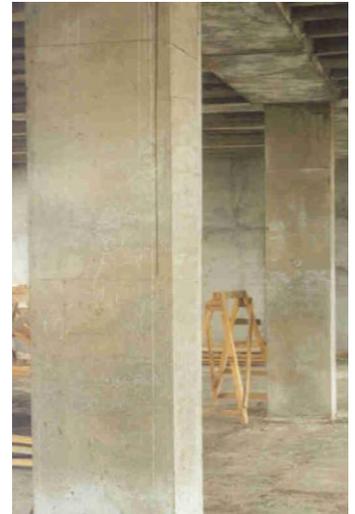
Figure 15 and 16. The repaired column

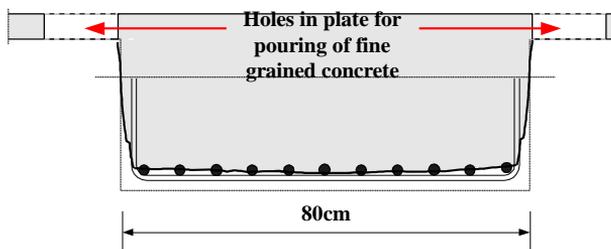
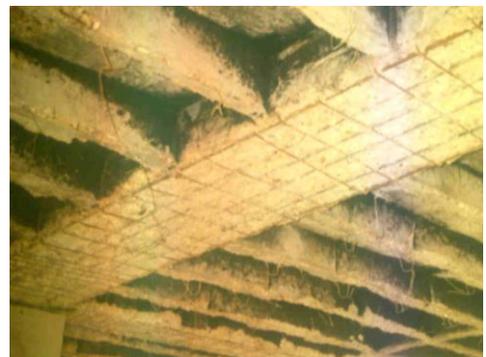
Figure 17 and 18. Removal of the damaged concrete cover and drilling a slab opening

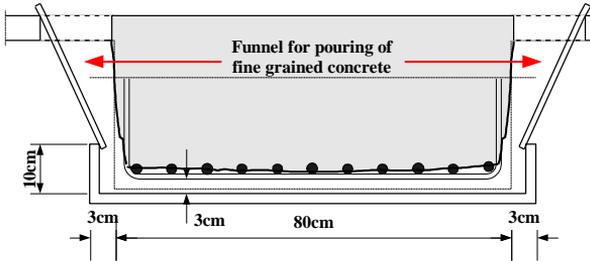
Figure 19. Placing of new cover on the down part of the beam

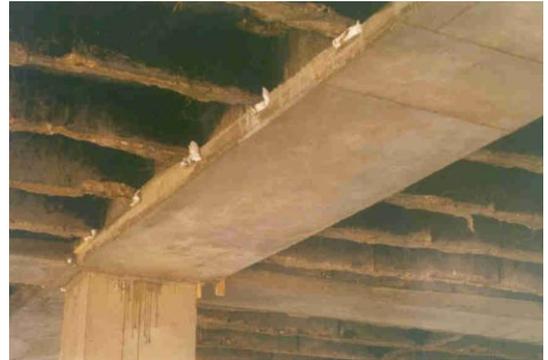
Figure 20. View of the new protective cover on the down part of the beam

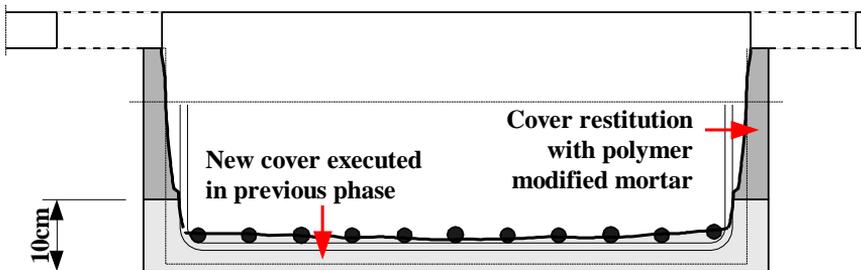
Figure 21. Applying the new protective cover on the side surfaces of the beam

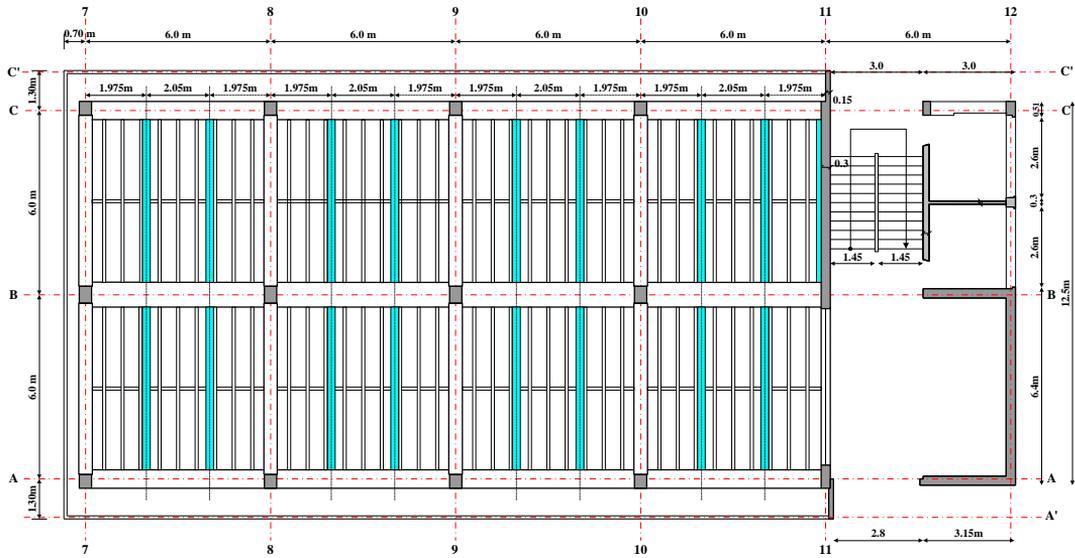
Figure 25. Disposition of the new beams in the existing slab

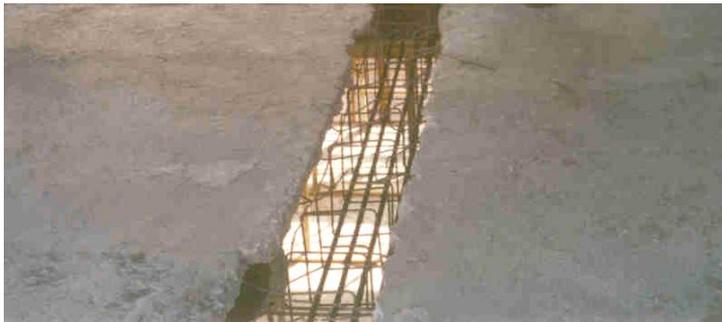
Figure 26. The reinforcement of the new beam

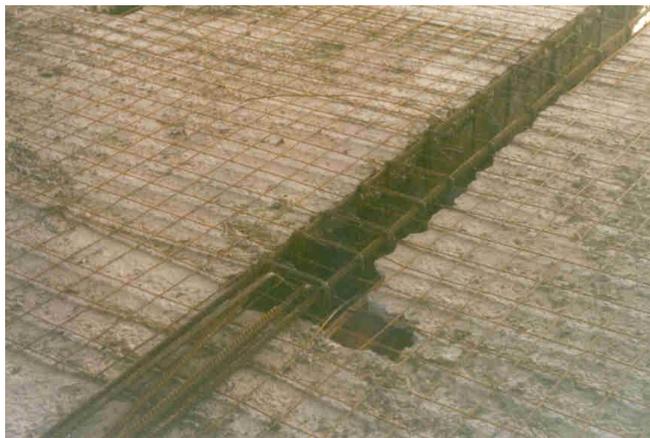
Figure 27. The wire-mesh reinforcement in the slab

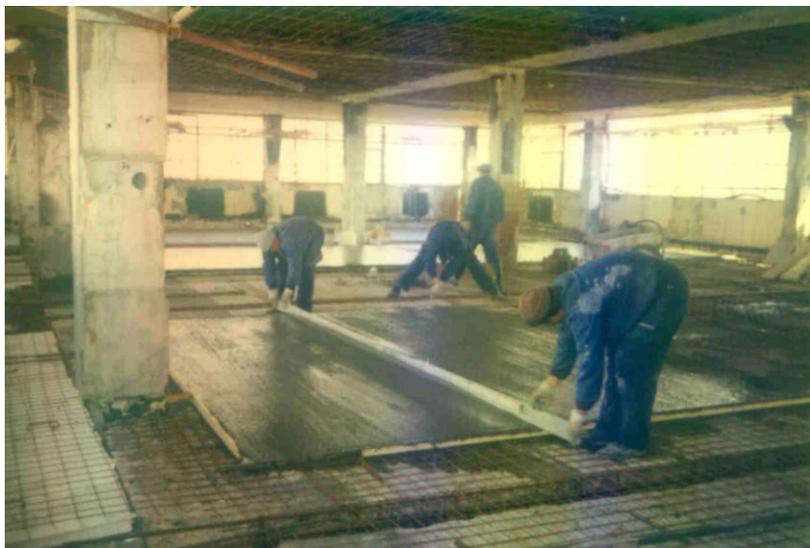
Figure 28. Concreting of the new slab
