# Knowledge FOR Resilient soCiEtY

*University of Tuzla*

# Repair and prevention measures of Cultural Heritage structures

## Chapel of The Virgin Mary in Lipnica

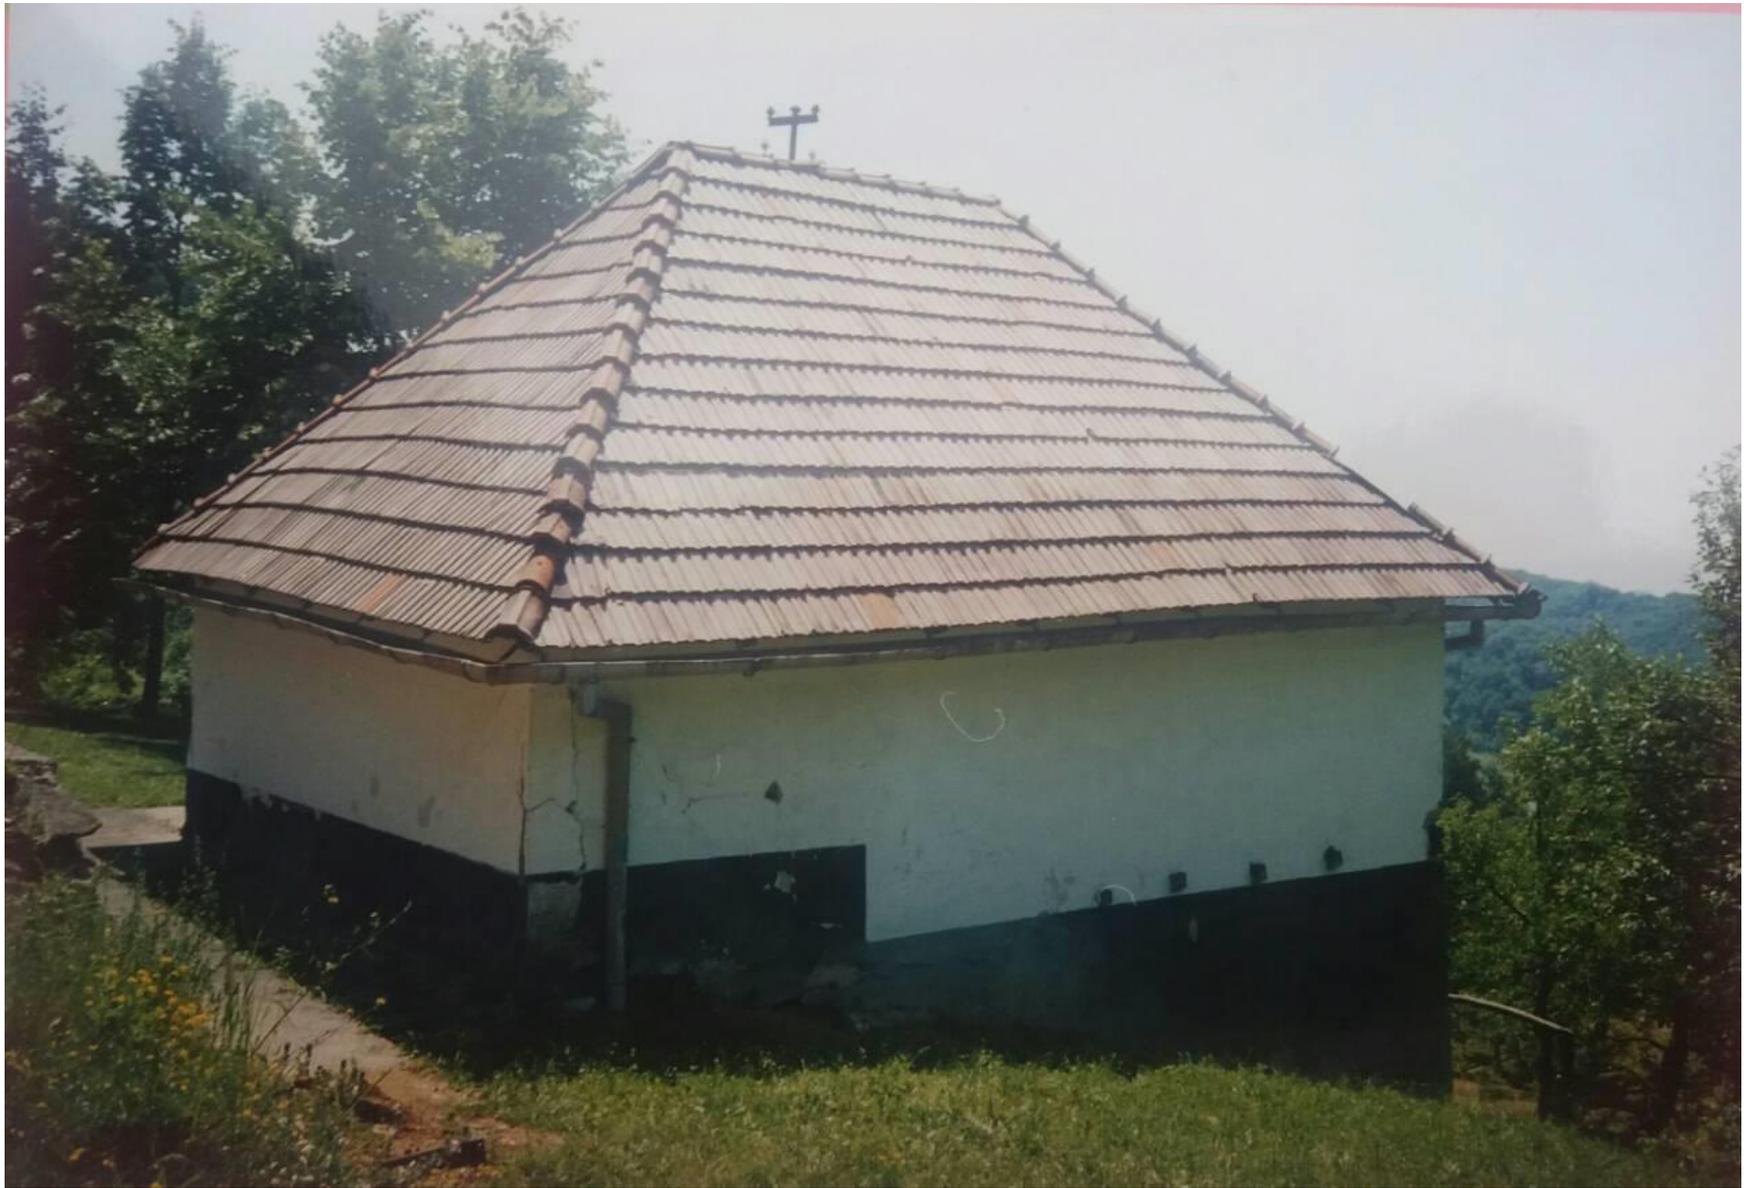
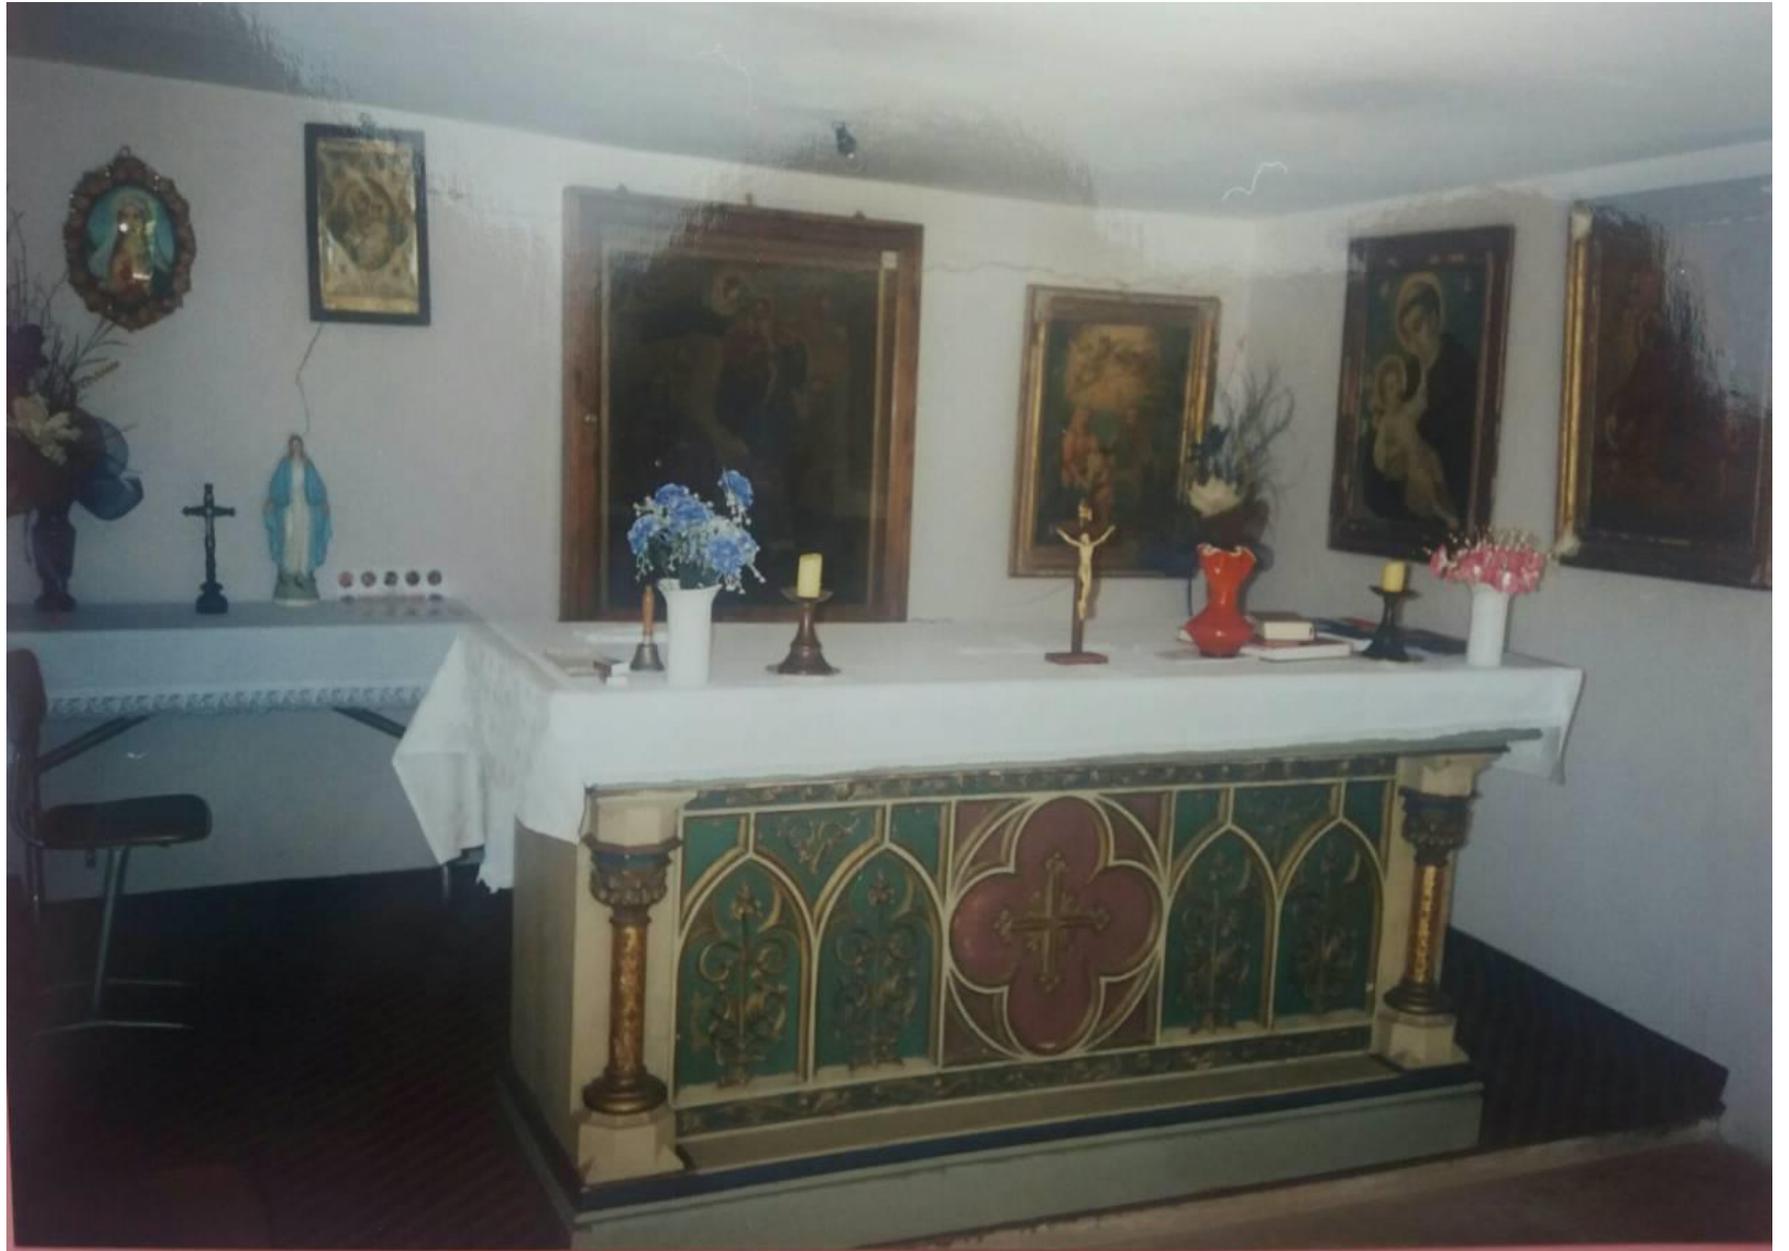
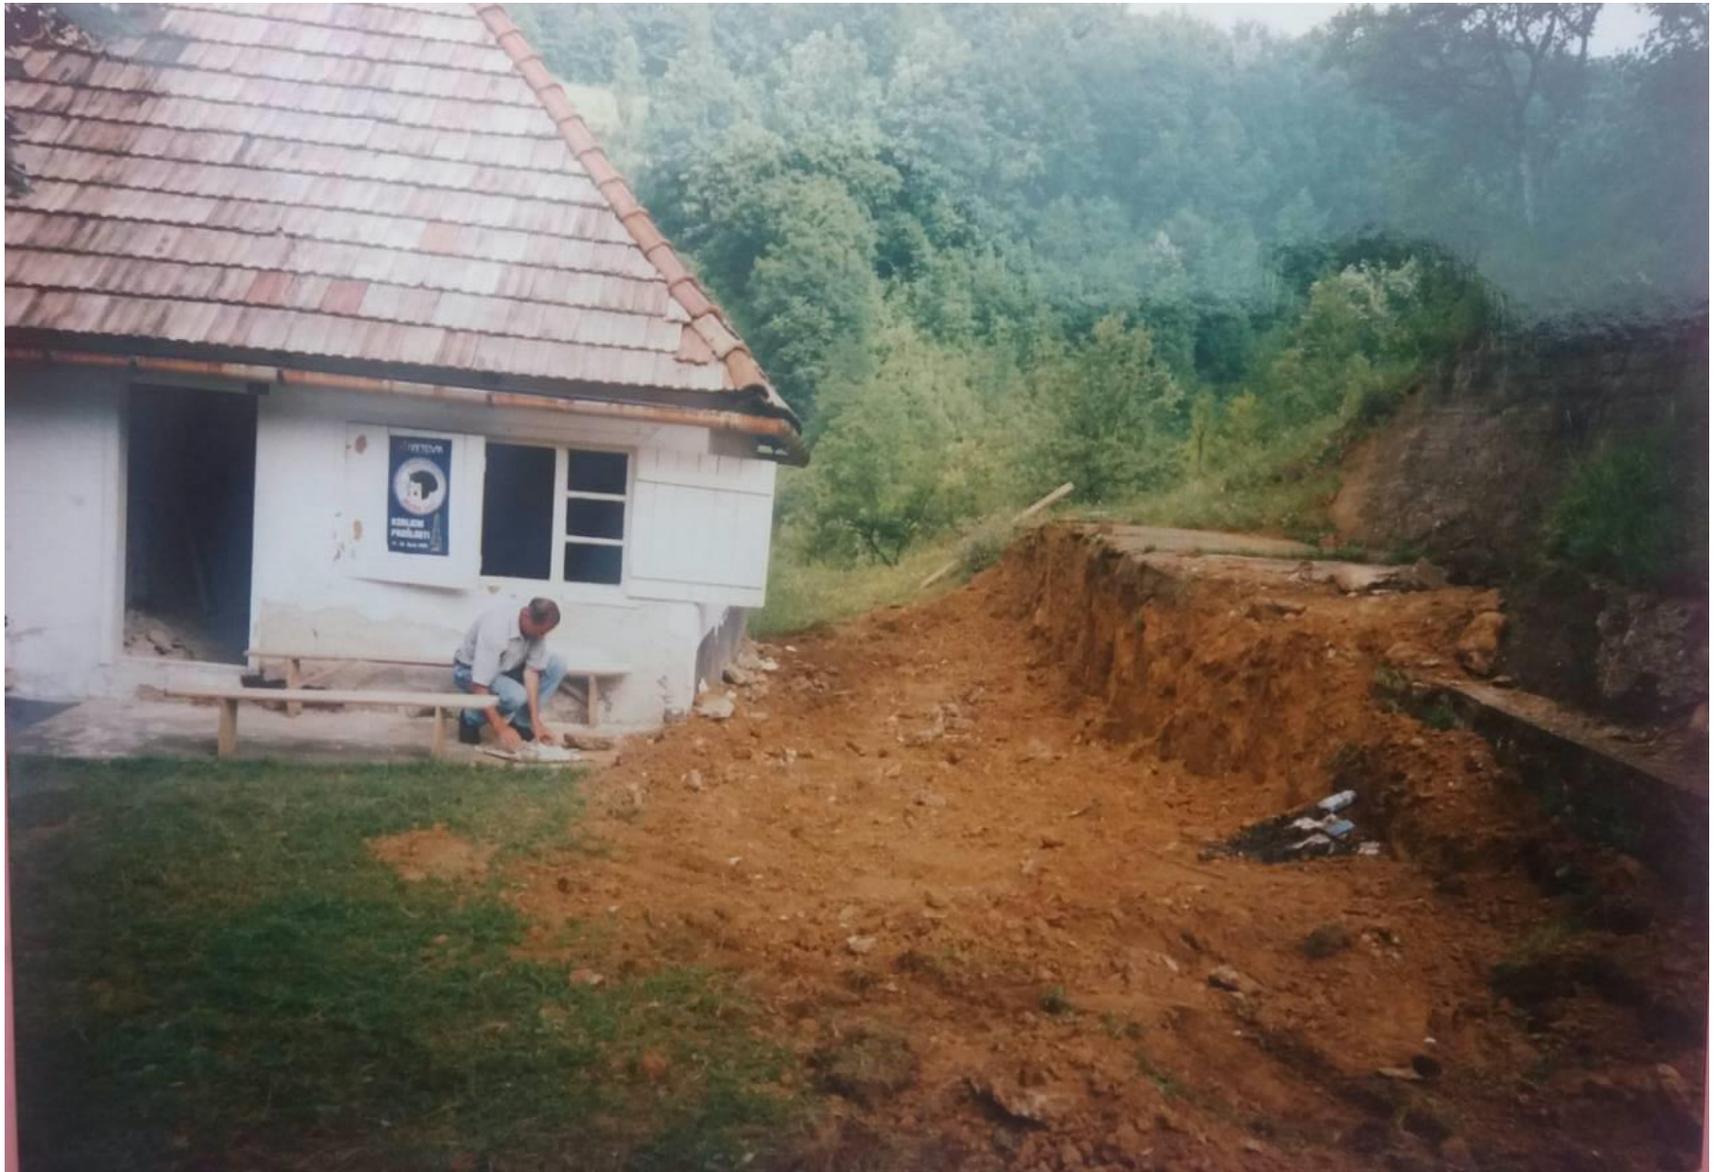
Landslide happened 2001 directly jeopardized monument and its construction.

Danger to the chapel was indicated by cracks on the north and west wall of the room for liturgy.

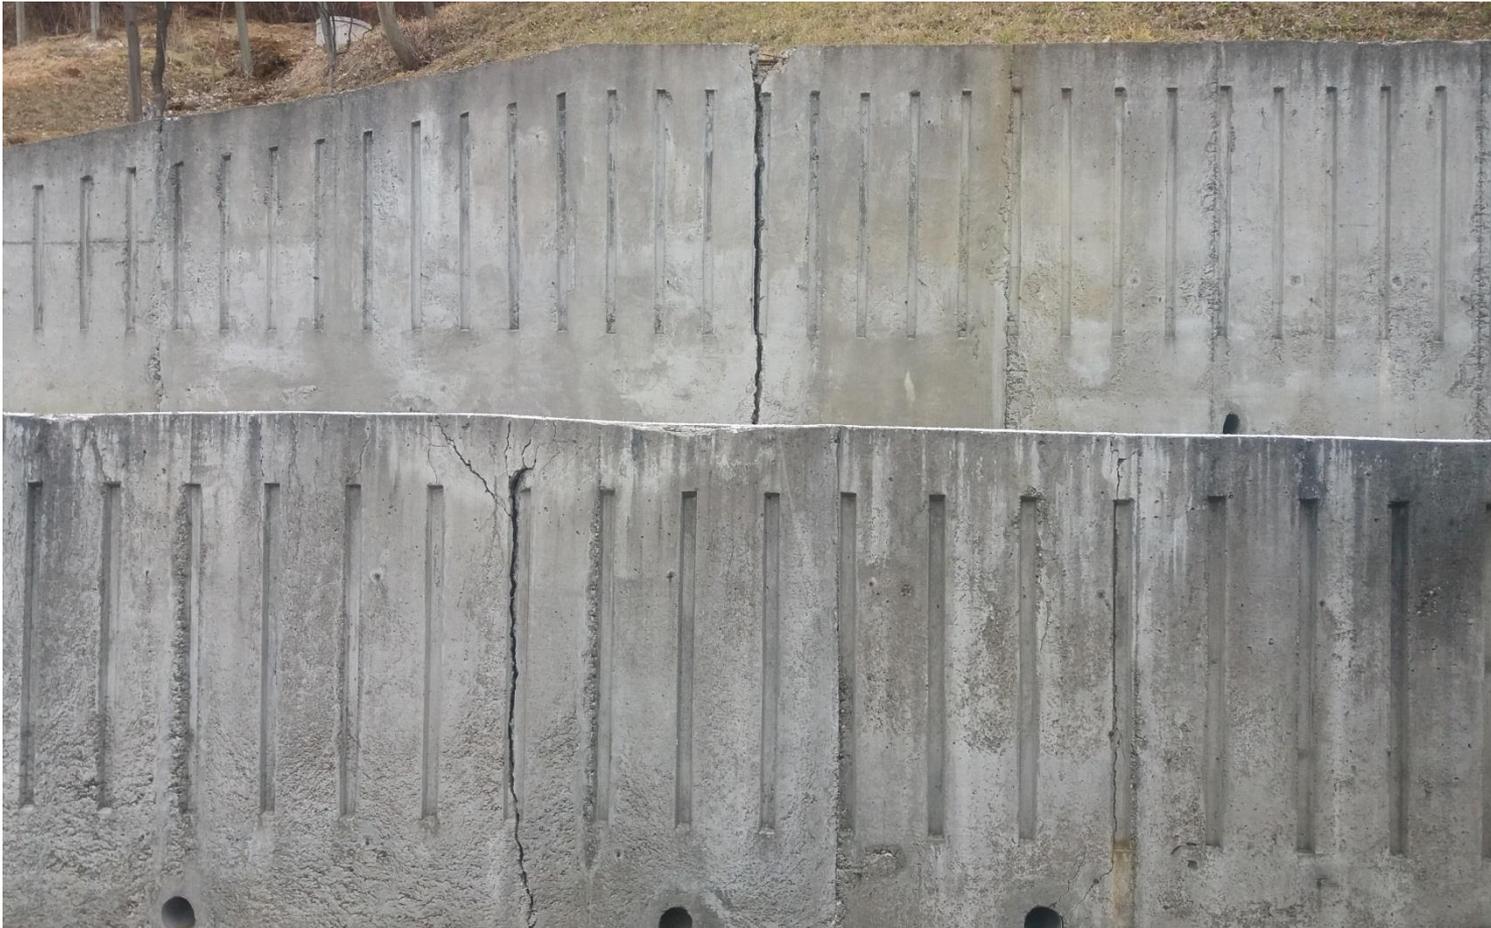
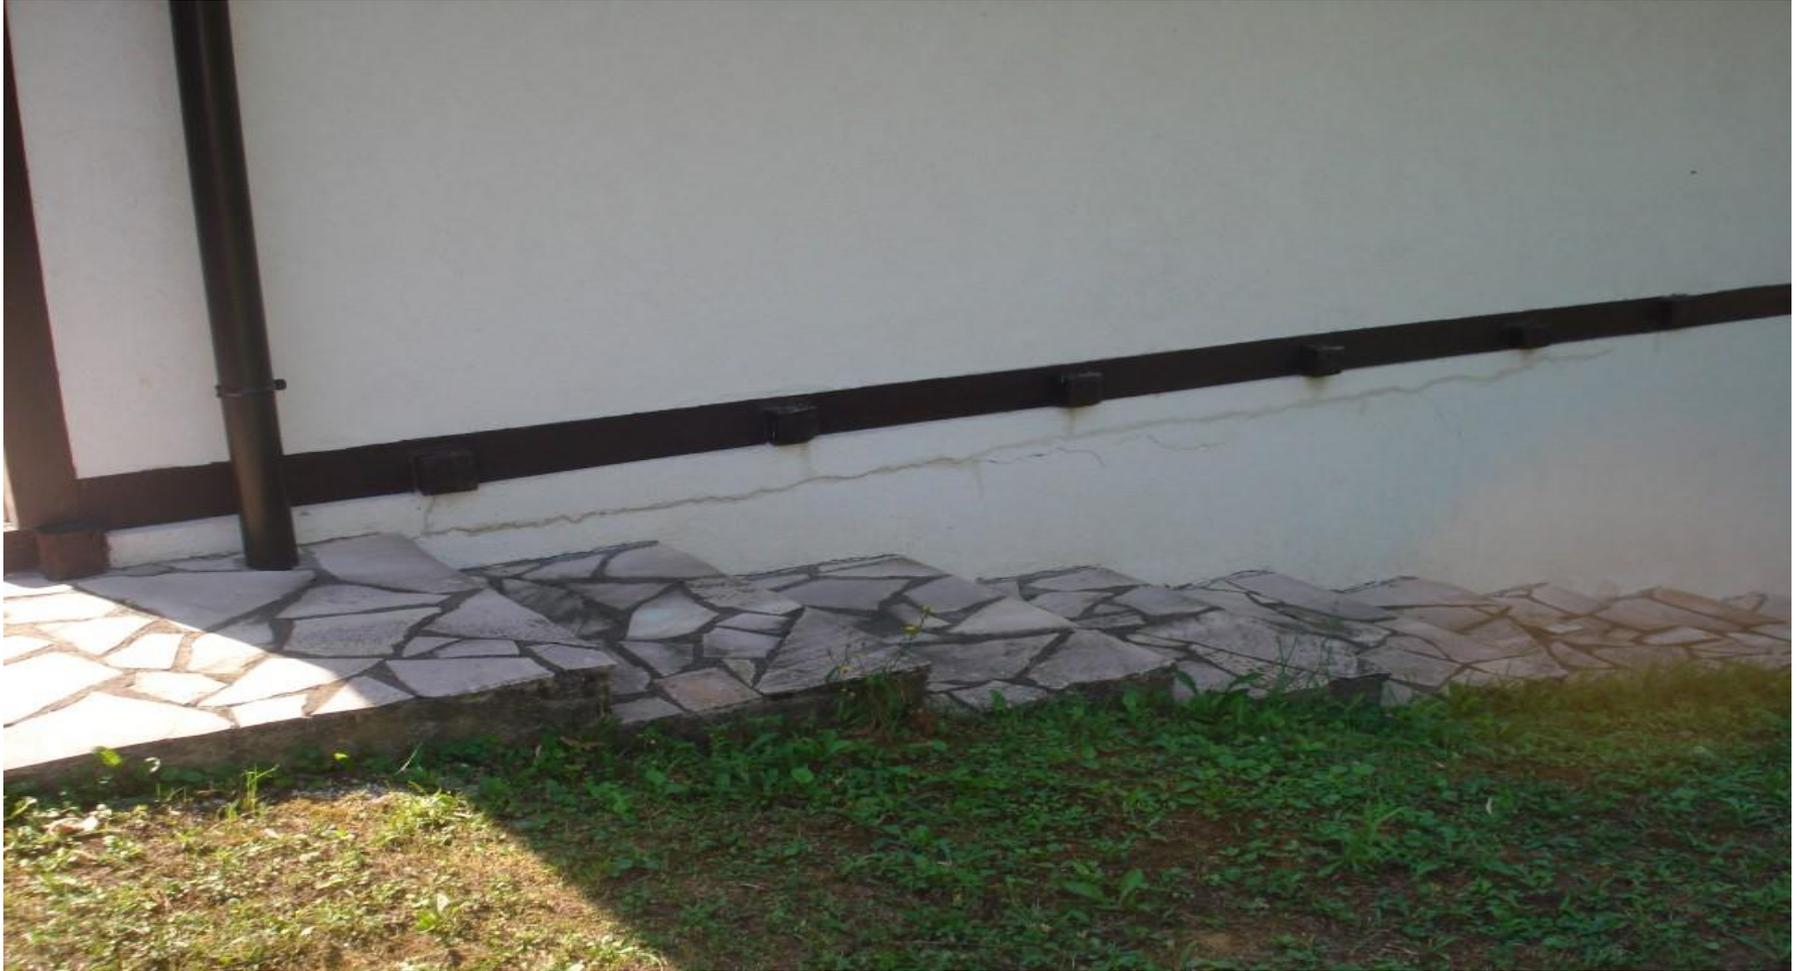
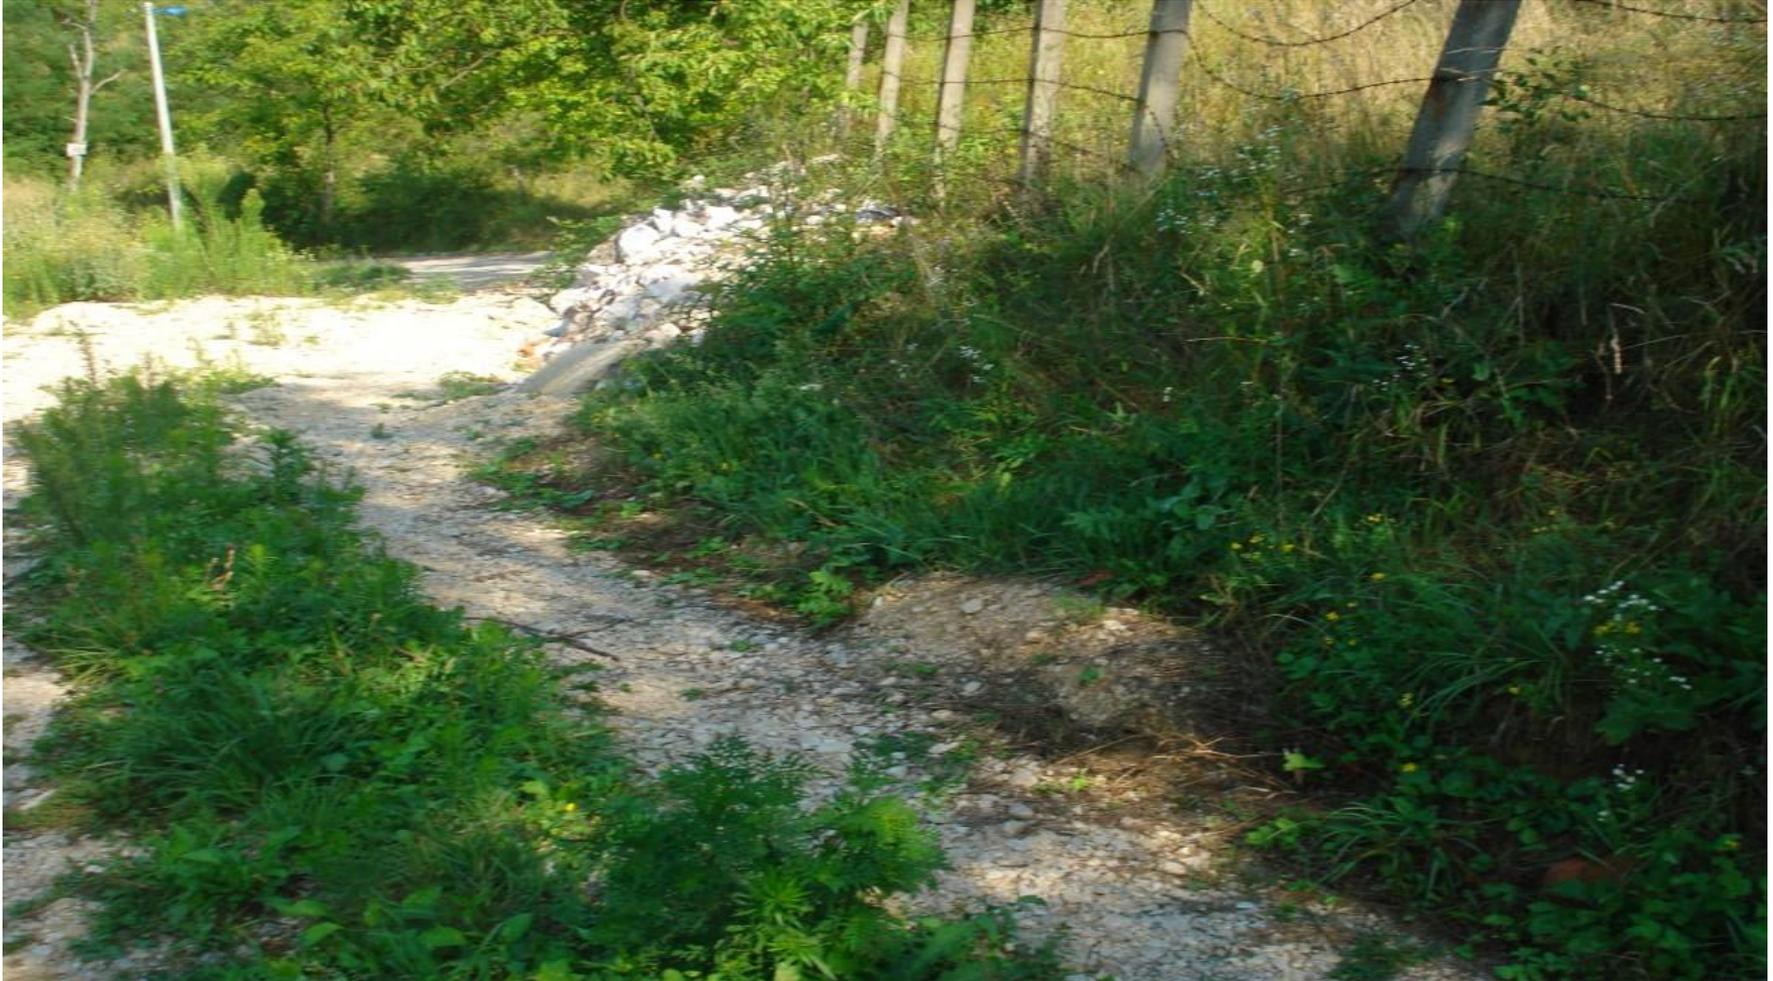
Due to bad weather conditions in 2014 landslide re-activated.

By re-activating the landslide on the already repaired part with the supporting wall, appeared cracks.

The slope was repaired by a deep drainage system.

The main drainage arm has a length of about 93 m, while the secondary drainage arms have a total length of about 78 m

The body of the road that is in the middle of the landslide is sanitized by the execution of four stone ribs, and the repair of a labile slope, above the edges of the access road, is carried out in the position south of the chapel.

The gabion-supporting wall was made in the length of about 12 m.

The wall is made up of 6 gabions of dimensions 1 x 1 x 2 meters, set on a reinforced concrete slab of about 15 cm thick.

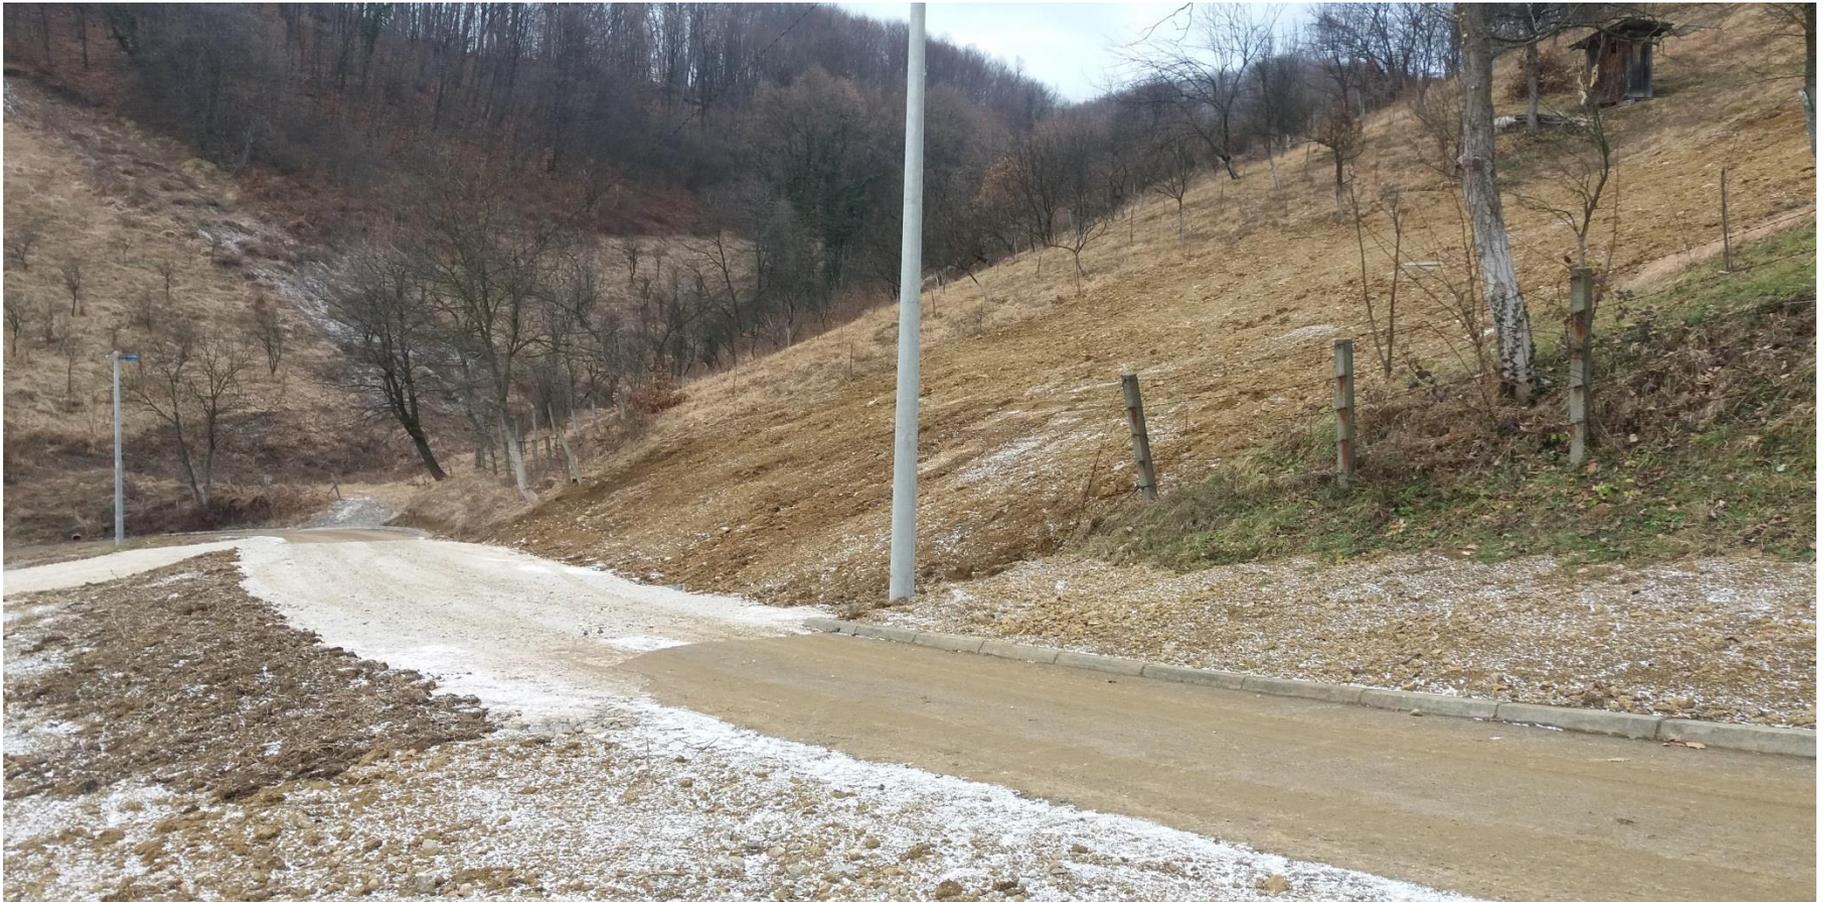
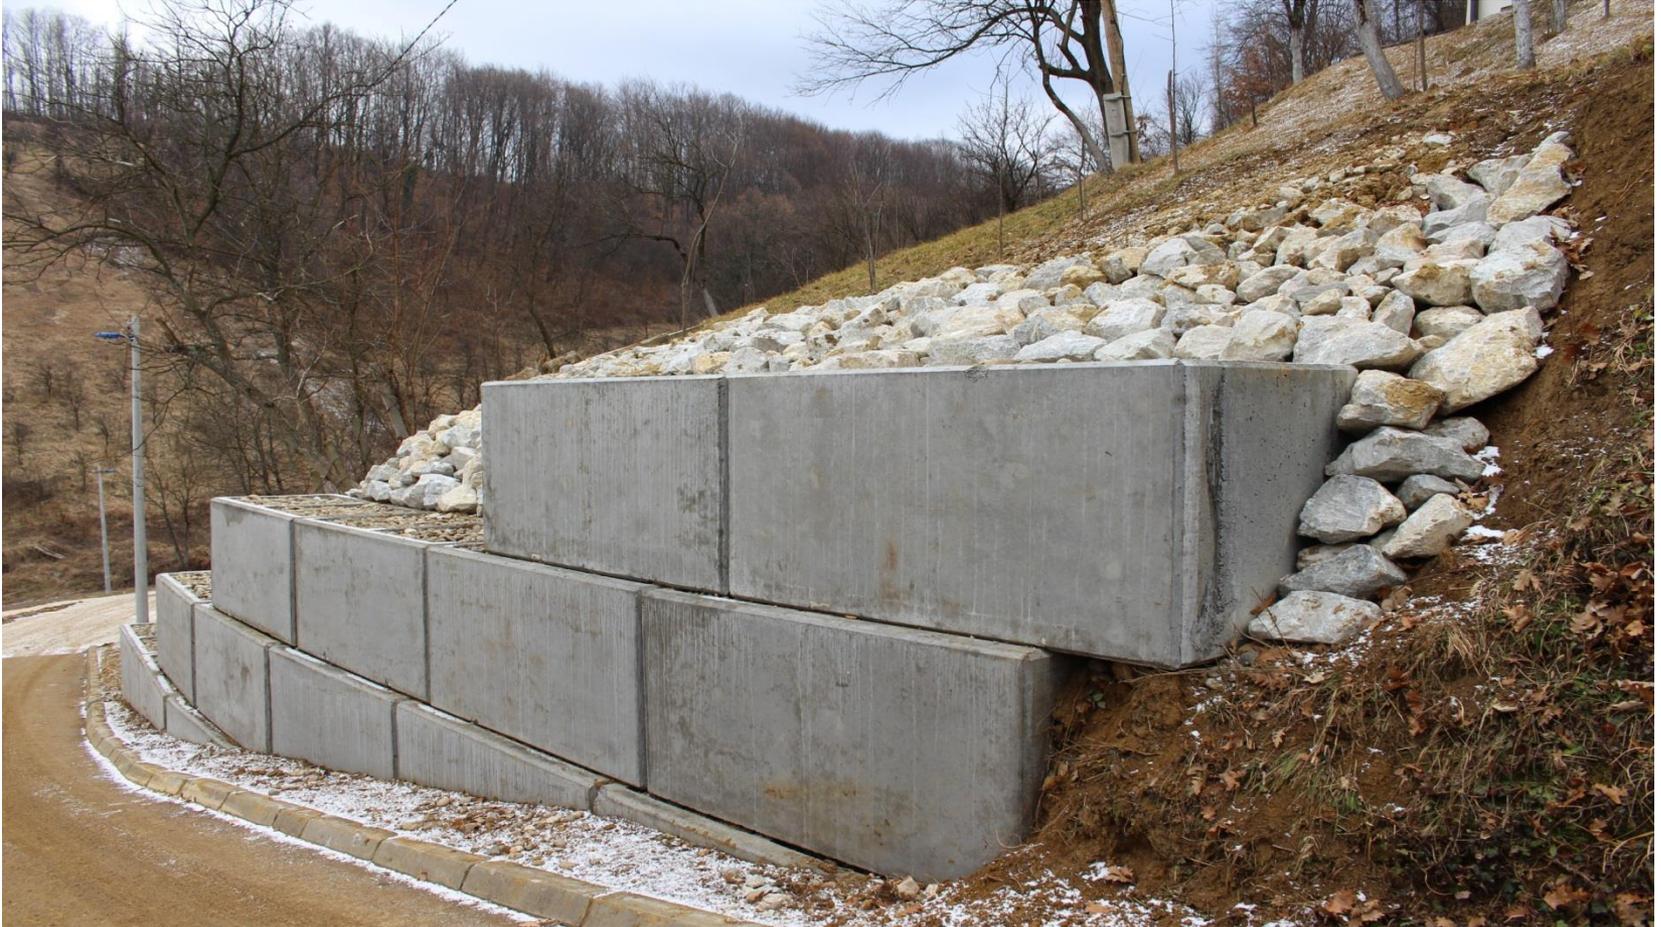
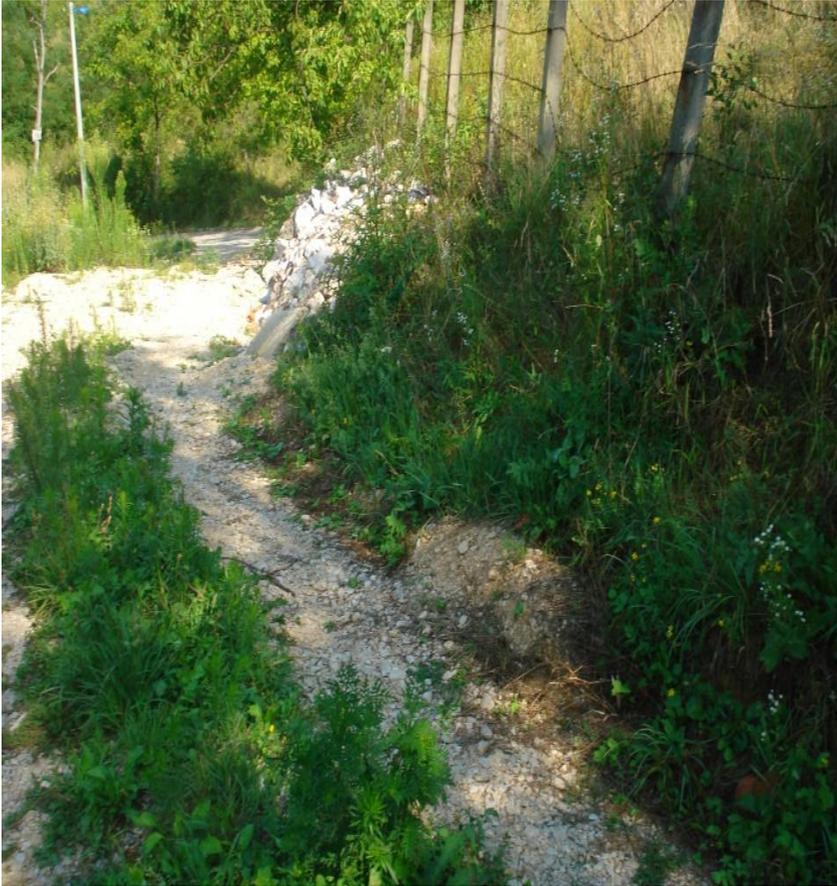
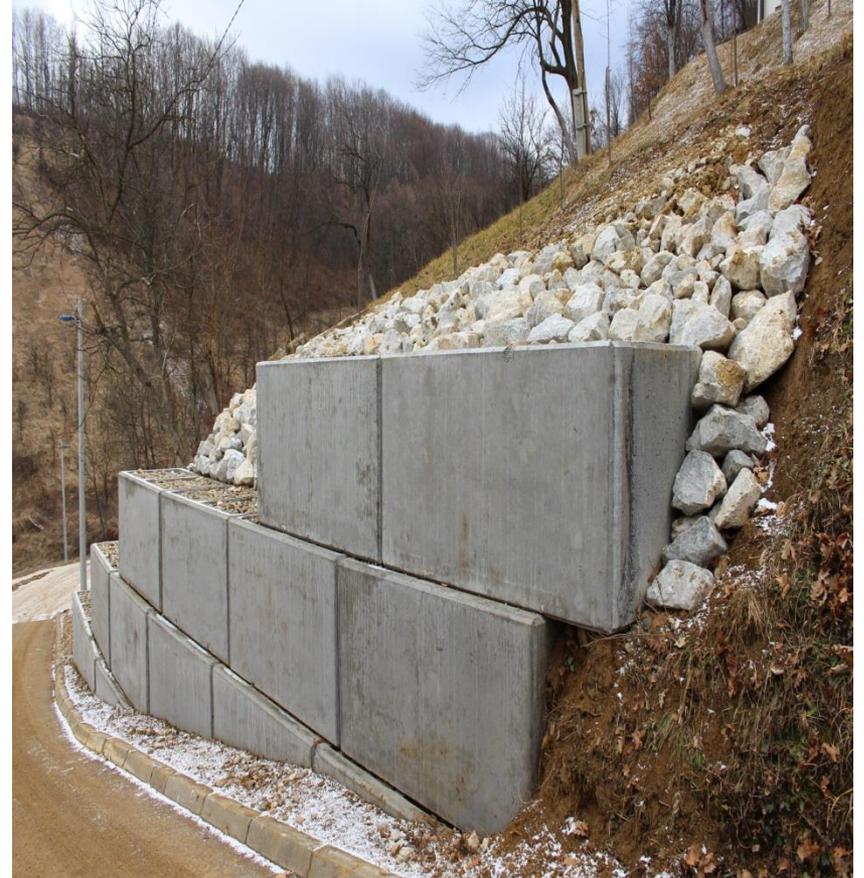
The appearance of shorter cracks implied the conclusion that the foundation was not sufficiently deep, and reinforced concrete levels were made in three places.

As part of this renovation project, concreting of the southern foundation wall of the chapel was carried out.

It is recommended reforestation of slopes as a prevention of the occurrence of landslides.
