MAY 2014 FLOODS IN SERBIA

Marina Babić Mladenović¹, Vasiljka Kolarov¹

¹ Jaroslav Černi Institute for the Development of Water Resources, Jaroslava Černog 80, 11226 Pinosava, Belgrade, Serbia; Marina.Babic-Mladenovic@jcerni.co.rs

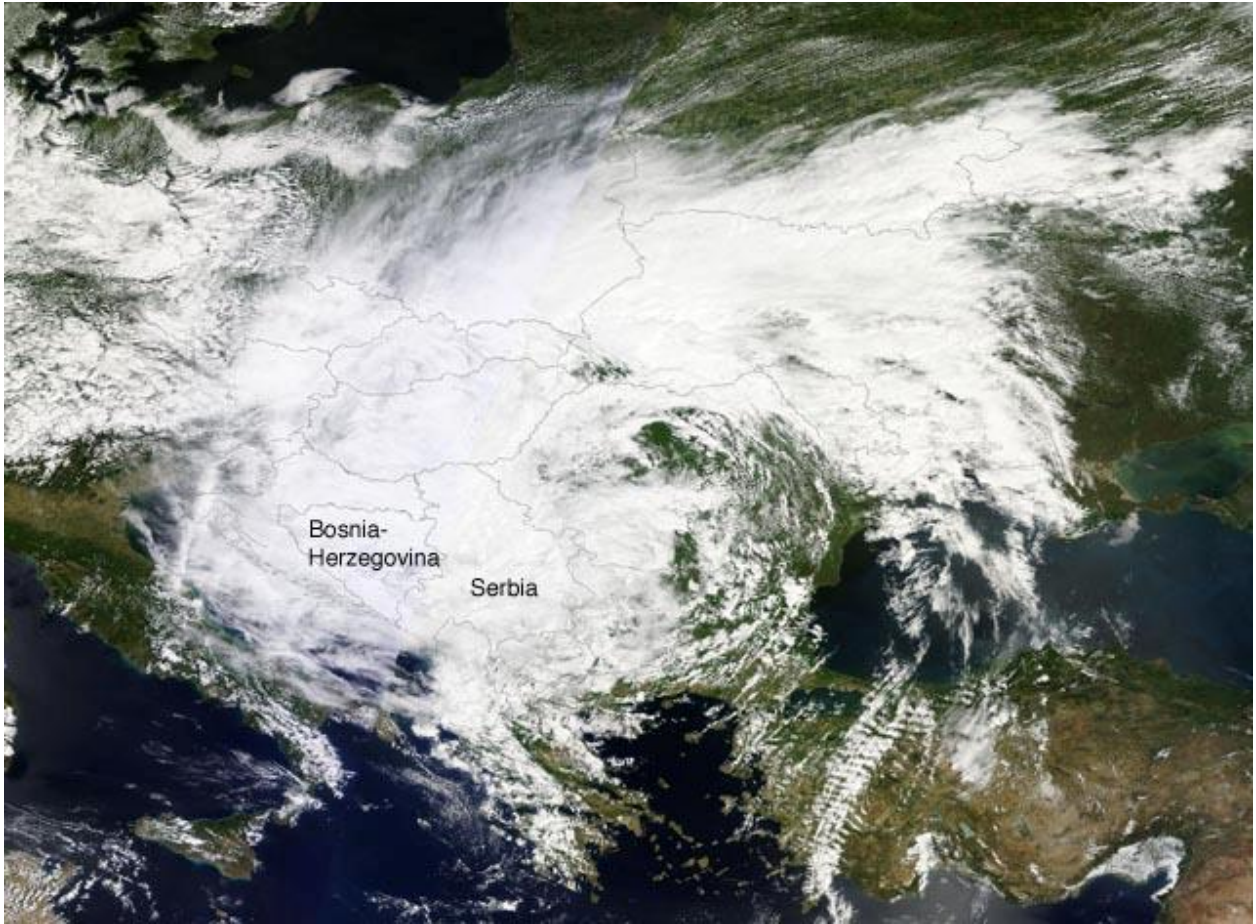
Figure 1. Cyclone Yvette on May 15, 2015 (source: NASA)

A low pressure system, named Yvette, developed over the Adriatic Sea on May 13, as polar air from Central Europe penetrated into the Mediterranean basin. The cold polar air mass met with humid subtropical air, leading to very low pressure. Meteorologists often describe this weather phenomenon as a Genoa Cyclogenesis. In May 2014, the centre of the cyclone moved from a Genoese bay over the Apennines, southern Adriatic, south of Serbia, Bulgaria and Romania. The most common path that Genoese cyclones has is in the direction of the Black Sea, where they usually finally diminish (Nišavić et al, 2014). In this case, Yvette has departed from usual path and made an elliptic loop over the south-eastern part of the Pannonian Plain. The cyclone moved very slowly (Figure 1), generating extremely high precipitation rates over Southeast Europe and the Eastern Alpine Region.

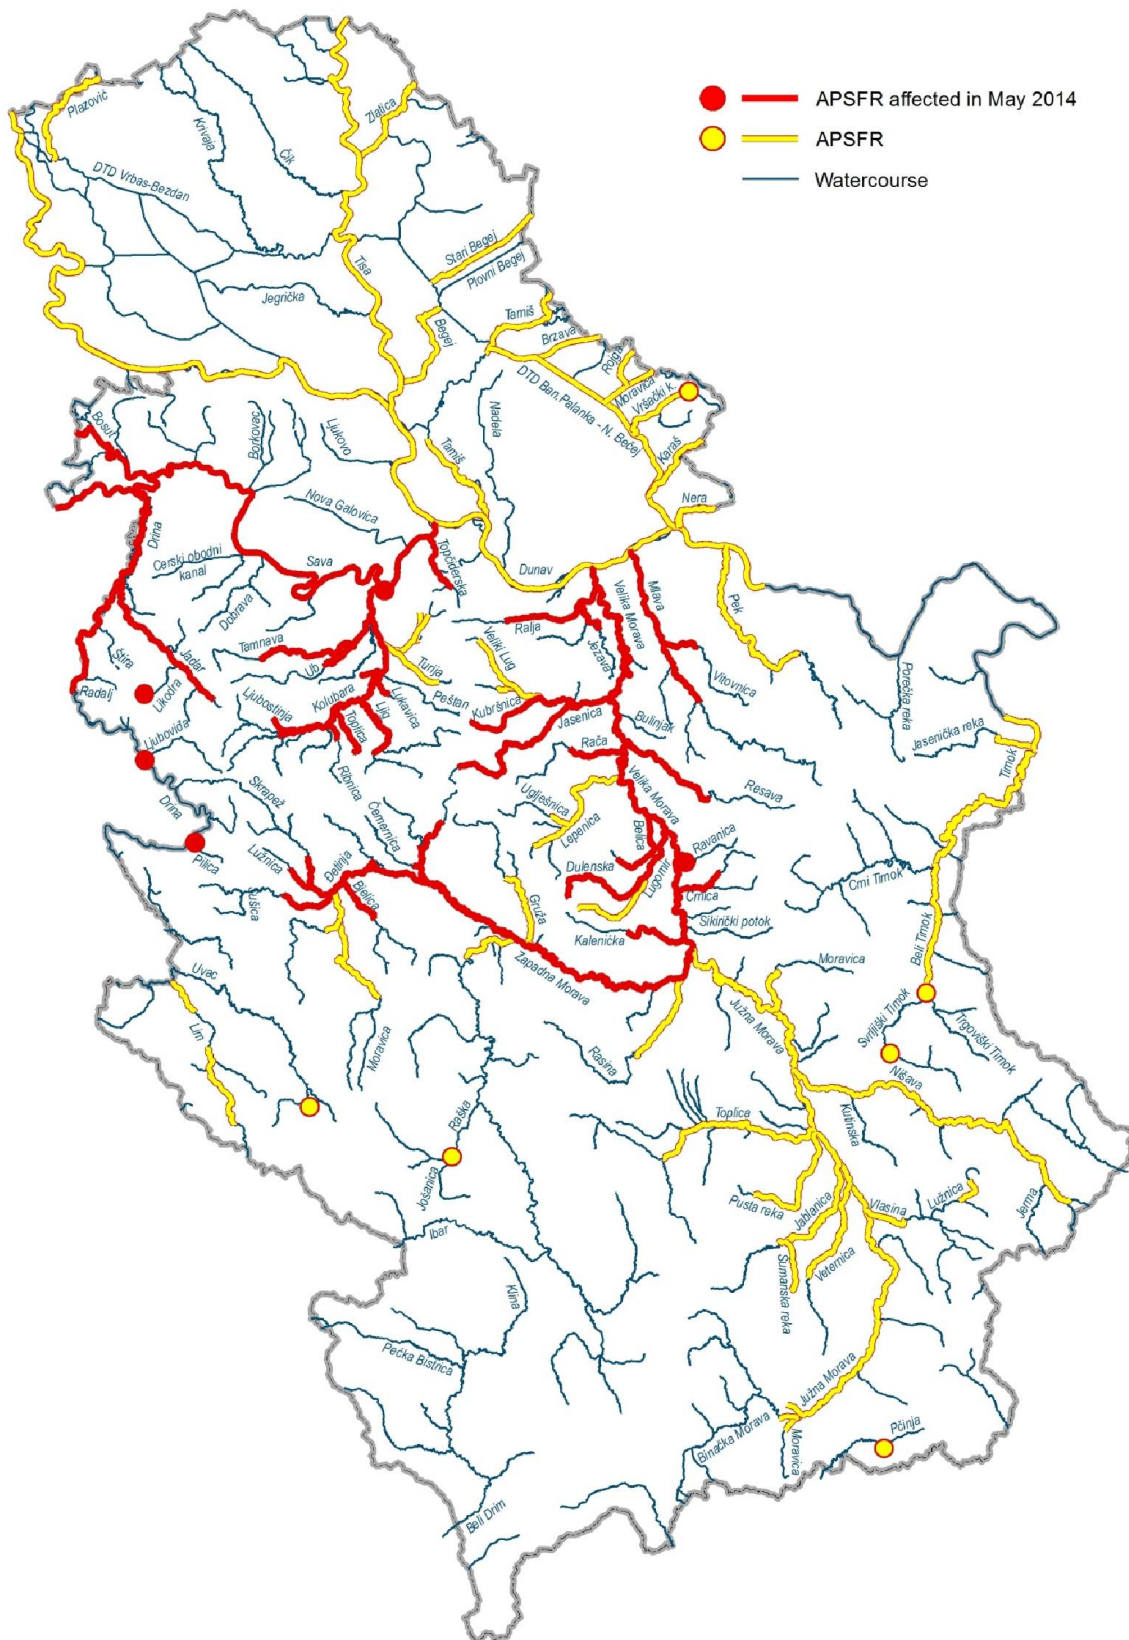
Figure 4. Areas with Potential Significant Flood Risk (source: IJC, 2011), and those affected by the May 2014 floods

Floods of May 2014 proved the proper identification of the Areas with Potential Significant Flood Risk (APSFR), as the result of the Preliminary Flood Risk Assessment, which was completed in 2012 for the territory of the Republic of Serbia. 99 APSFRs were identified along 95 rivers. Figure 4 shows those APSFRs which were affected by the May 2014 floods. Floods occurred along other rivers, which were not identified as APSFRs in 2012, as well. The significance of the damage caused by floods along these rivers shall be further analysed and in the following planning cycle the list of APSFRs may be amended.

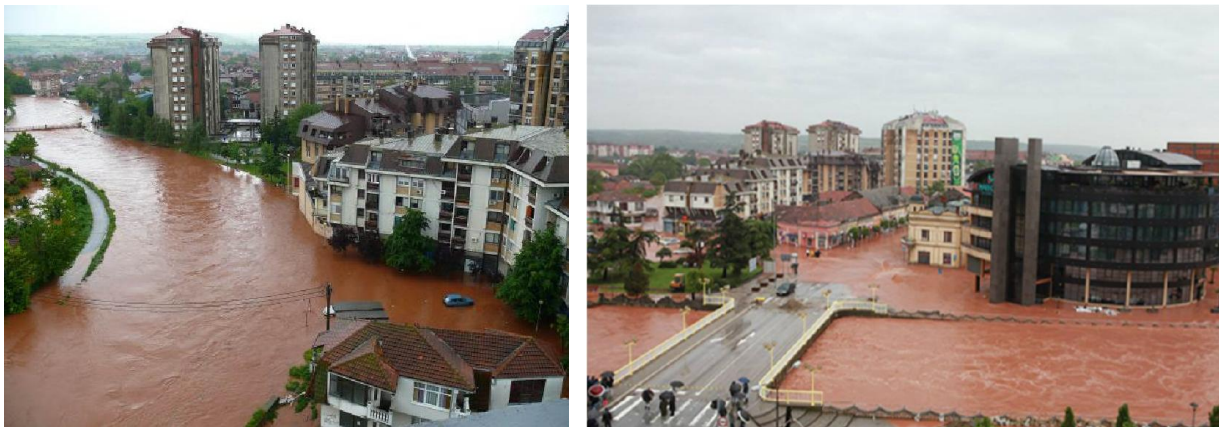
Figure 5: Scenes from the 2014 flood in Paraćin

Paraćin is a good example of a town where a small river, the Crnica, caused considerable damage. The expert opinion was prepared by the Jaroslav Černi Institute in March 2015, and it included hydrological and hydraulic computations, as well as proposal of future actions. The conclusion was that, although the river was trained within the town (design flood is 180 m³/s), the channel was overtopped because it did not have sufficient capacity to convey flood waters, especially near bridges. Hydraulic reconstruction revealed that peak of May 2014 flood was 260 m³/s. The upgrade of flood protection system is planned for near future, and it will encompass elevation of banks along the river and use of flood retention ponds upstream of the city.

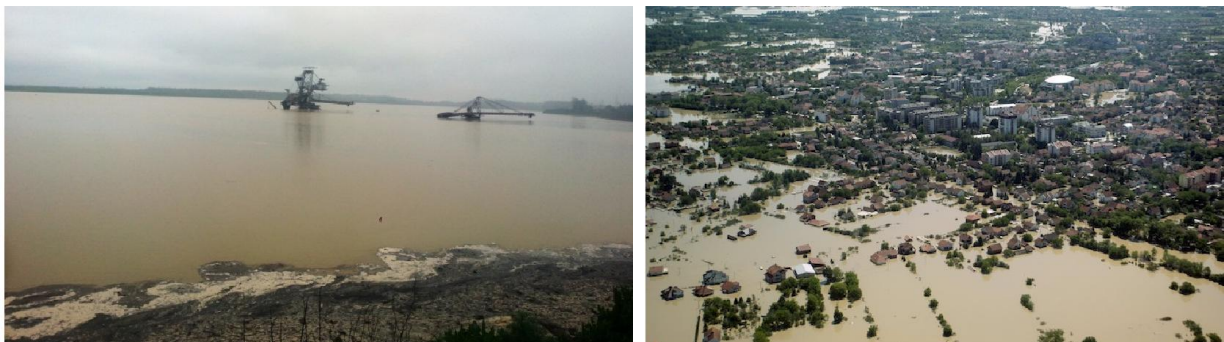
Figure 6: Scenes from the 2014 flood in the Kolubara river basin (left: flooded "Tamnava – West Field", right: flood in Obrenovac)

In May 2014, numerous tributaries of the Kolubara had extremely high flows and the flood caused damage to settlements, infrastructure and farmland. At the Kolubara River, the flood defenses within the City of Valjevo sustained considerable damage (with minor overtopping in the city center), the bridges were either damaged or destroyed, and the open pit coal mine "Tamnava – West Field" was flooded with some 200 million m³ of water.

The entire City of Obrenovac, was flooded because the dikes were breached some ten kilometers upstream from the city. In parts of the flooded area, the flood waters were several meters deep. When the Sava levee failed at two locations, the water from the flooded area gravitated to the Sava as much as possible due to a highly unfavorable configuration of the terrain on which the city is located. Namely, some residential areas are situated on very low-lying land – abandoned branches of the Sava and the Kolubara, from which flood water had to be pumped.
