# 2ND INTERNATIONAL SYMPOSIUM K-FORCE 2019

## EFFECTS OF HIGH TEMPERATURES ON CONCRETE MICROSTRUCTURE

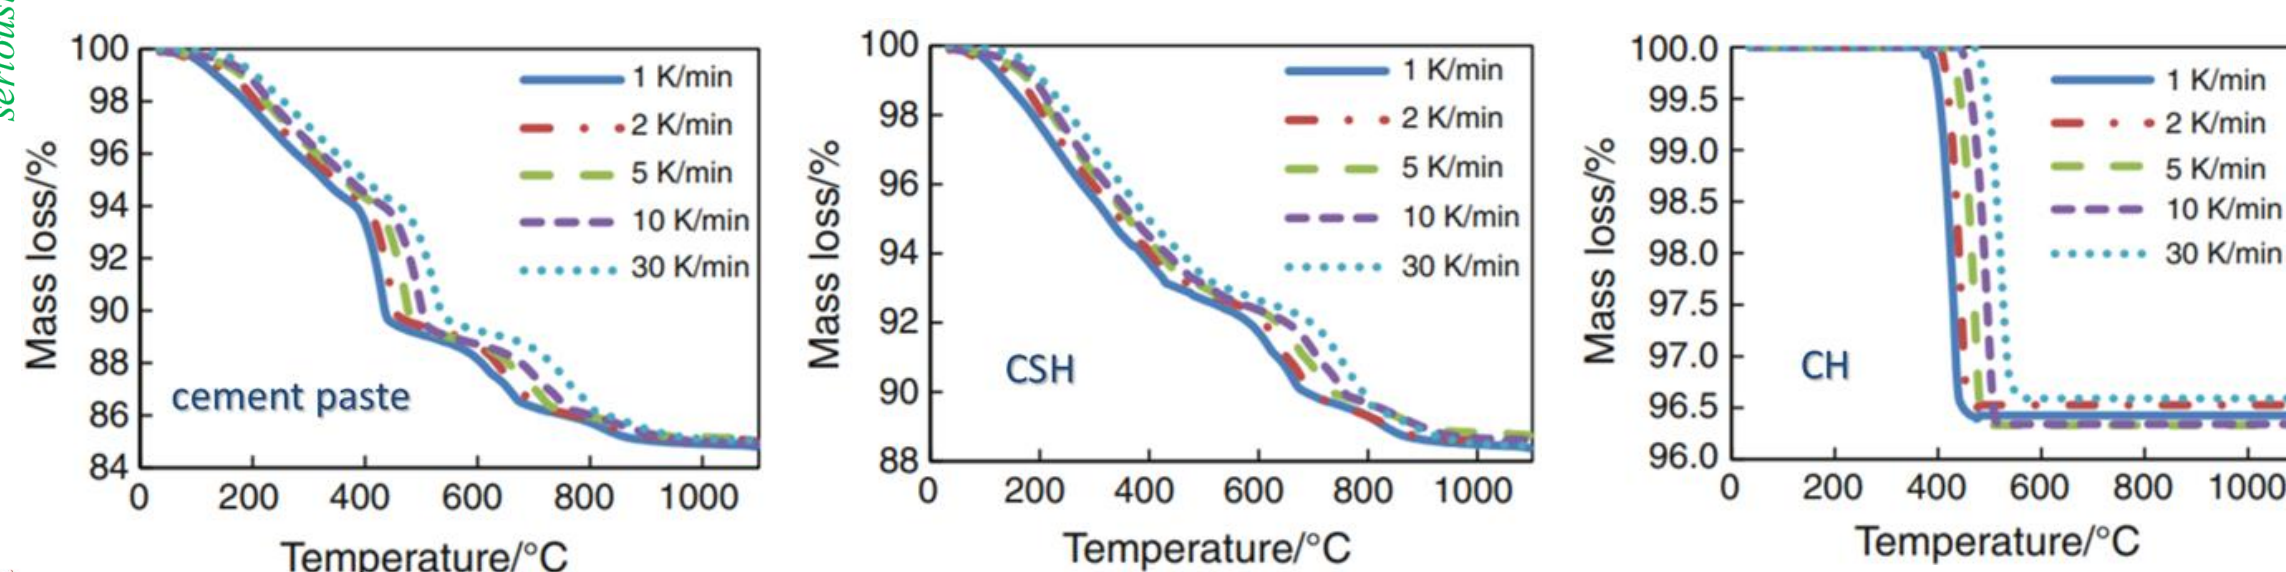
According to experimental research on cement paste dehydration at high temperatures, range of the temperature corresponding to the dehydration of the cement paste varies with the heating rate. It was found that for the samples of the cement paste with different heating rate, the dehydration starts at the same temperature, but ends at different temperature.

The mass loss of cement paste, CSH and CH under different heating rates

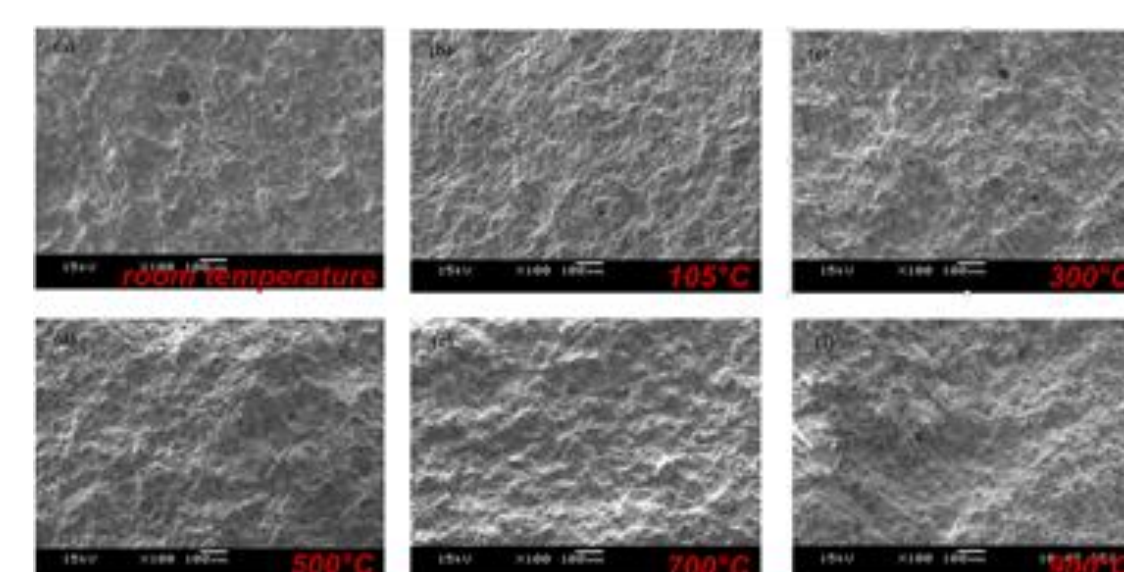
SEM images of fractured surfaces of cement paste in 100× magnification

- ambient temperature** - CH and C-S-H crystals remained intact
- 105°C** - slight increase in surface toughness, but without any other changes
- 300°C** - the degradation of hydration products started
- 500°C** - the microcracks appeared at their interface, with propagation between the anhydrous phases and the paste matrix
- 700°C** - microcracks got more intense and the paste porosity increased
- 900°C** - some particles are totally cracked

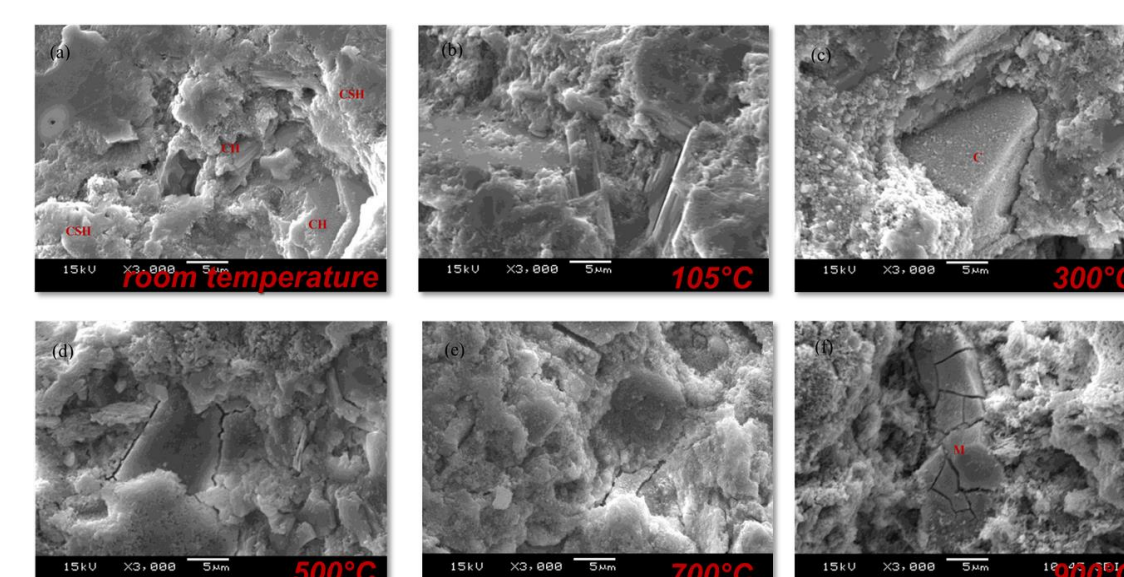
SEM images of fractured surfaces of cement paste in 3000× magnification
