EARTHQUAKE PROTECTION OF HISTORIC BUILDINGS AND MONUMENTS IN REPUBLIC OF MACEDONIA

Dr. Veronika SHENDOVA
University Ss. Cyril and Methodius in Skopje

IZIIS' EXPERIANCE

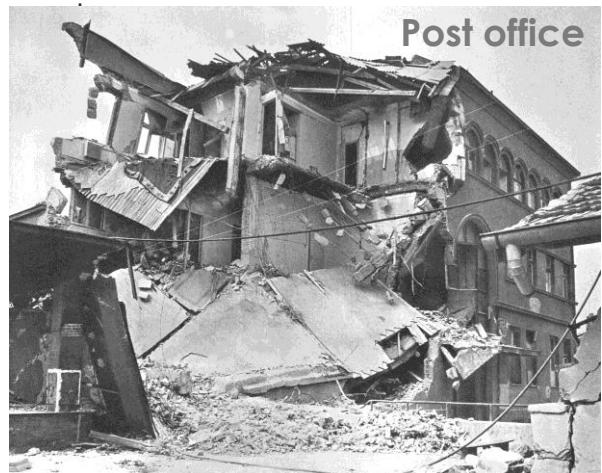
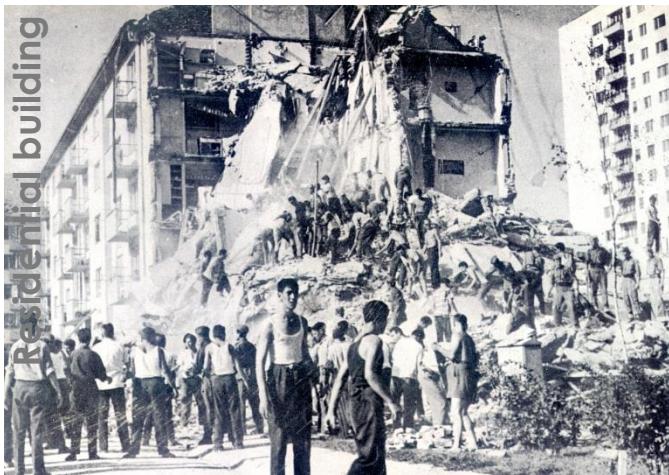
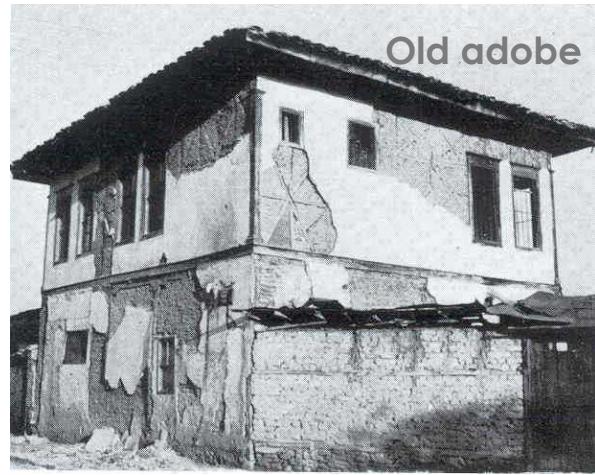
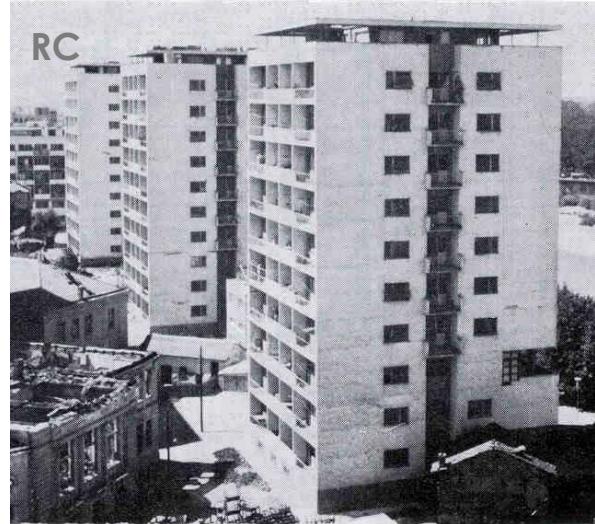
1963 Skopje Earthquake: M=6.1 1070 deaths 3300 injured

- Brick wall structures - the most damaged
- Mixed construction - considerably damaged
- Old adobe structures (timber bracing) - some damage
- RC frame - slightly damaged

Damage degree	Residential buildings	Other buildings	Housing area	Percent of population
Destroyed	11.3	9.2	7.0	8.5
Heavily damaged	44.1	33.0	29.9	36.4
Damaged	22.0	32.9	39.9	30.6
Slightly damaged	16.5	20.1	19.8	20.3
Undamaged	6.1	4.8	3.4	4.2

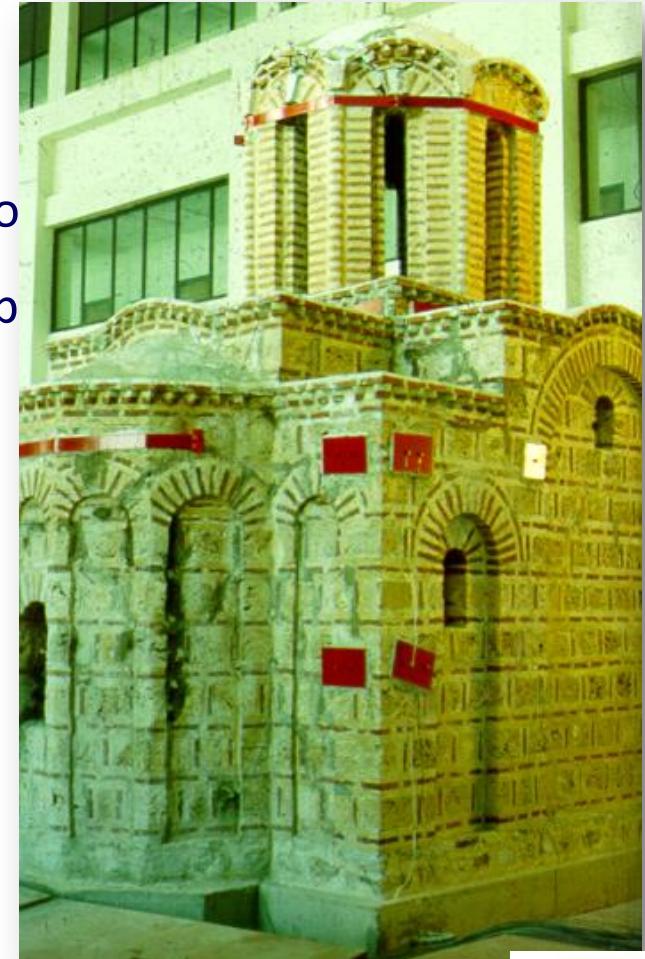
Selected method for strengthening:

- ← ***incorporation of horizontal steel ties***
- ← ***systematic injection of elements***
- ← ***incorporation of vertical steel ties***

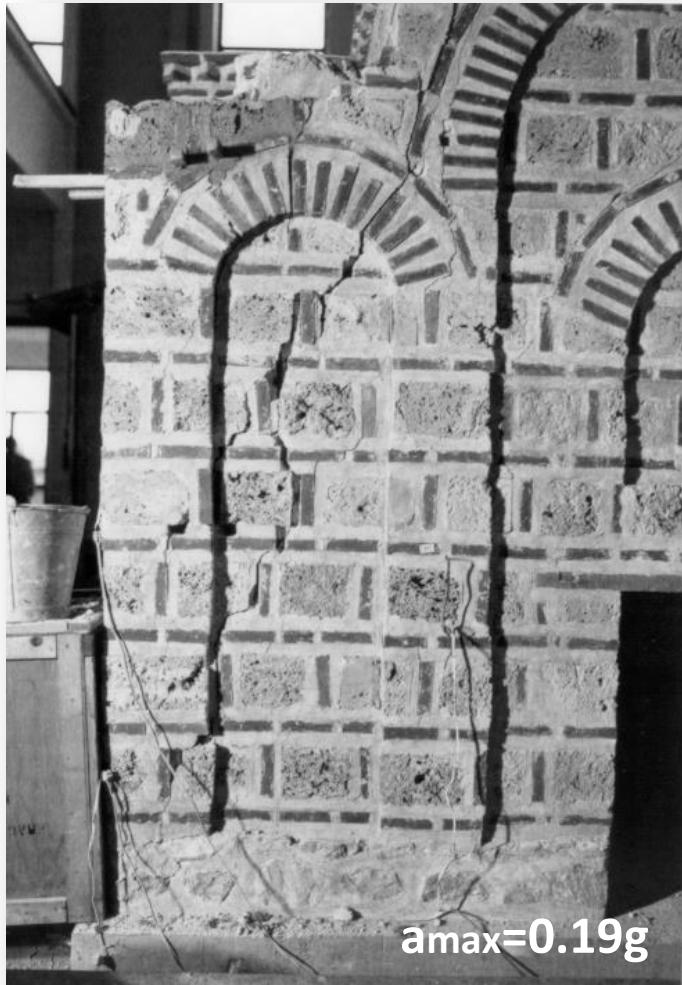
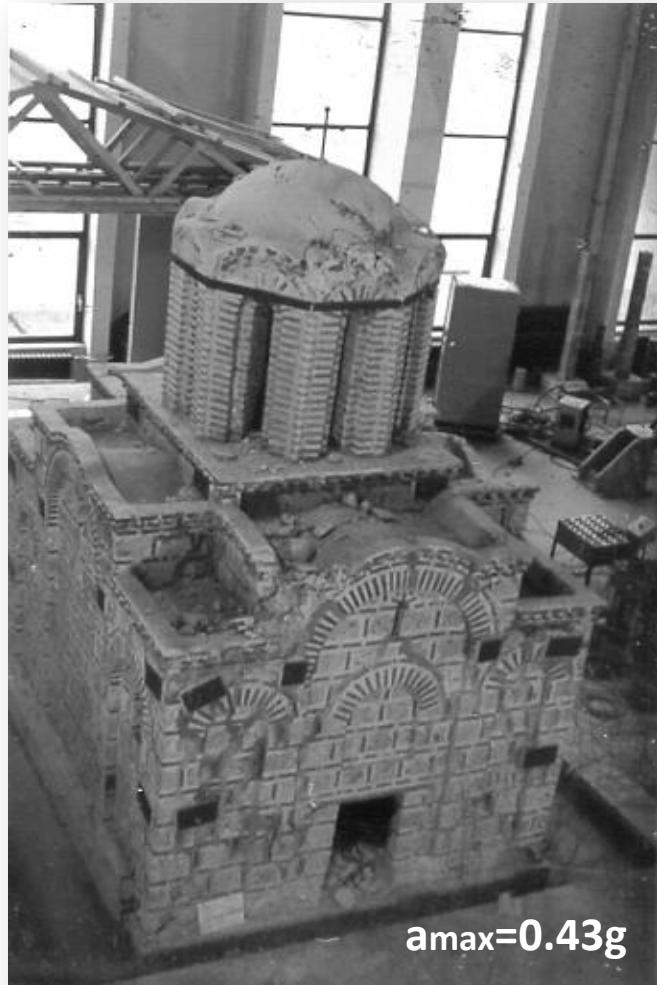
Experimental verification of methodology

lower damage level even under higher level of input excitation

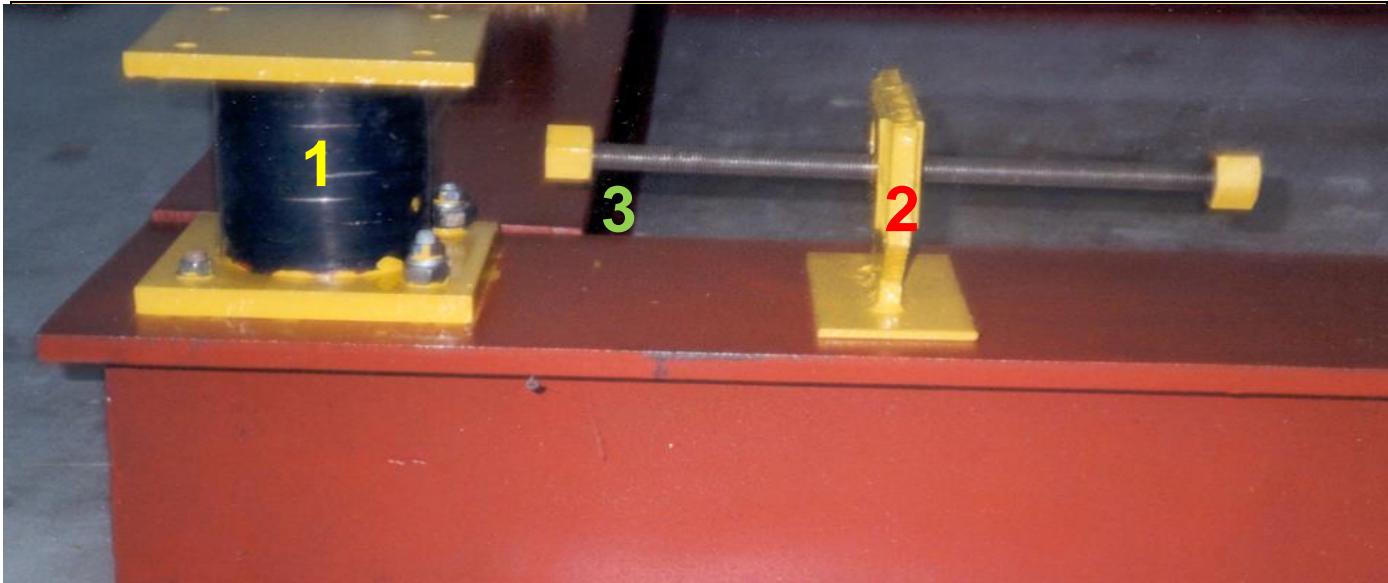
element 1: Laminated rubber bearing element

element 2: Steel plate damper (hysteretic behavior)

element 3: Stopper element (limited displacement)

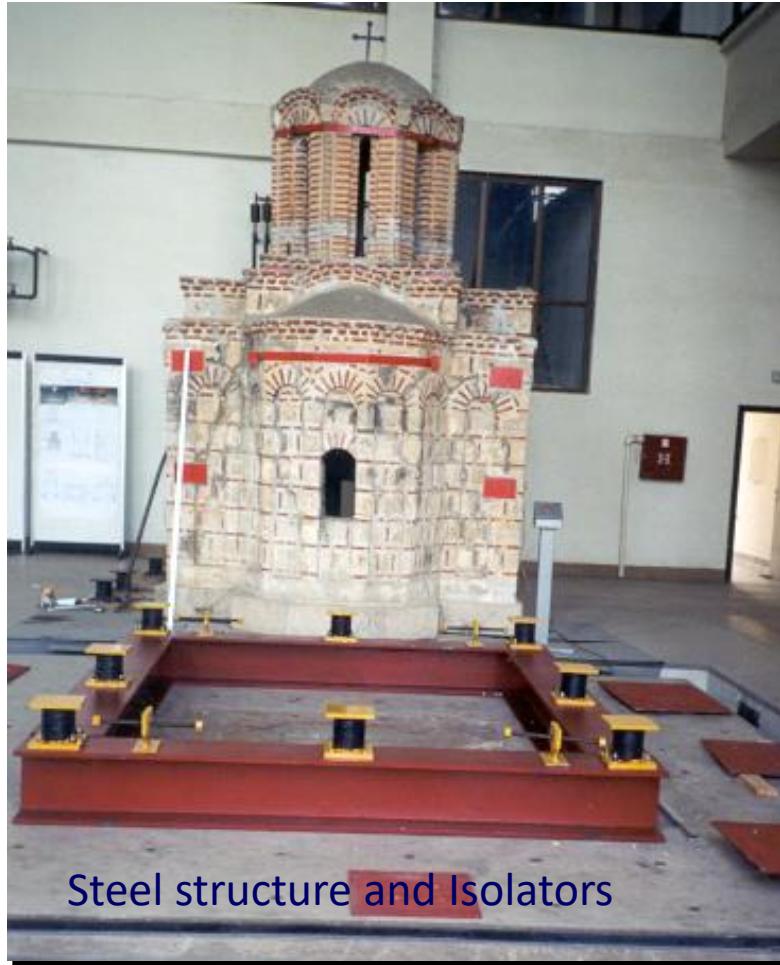
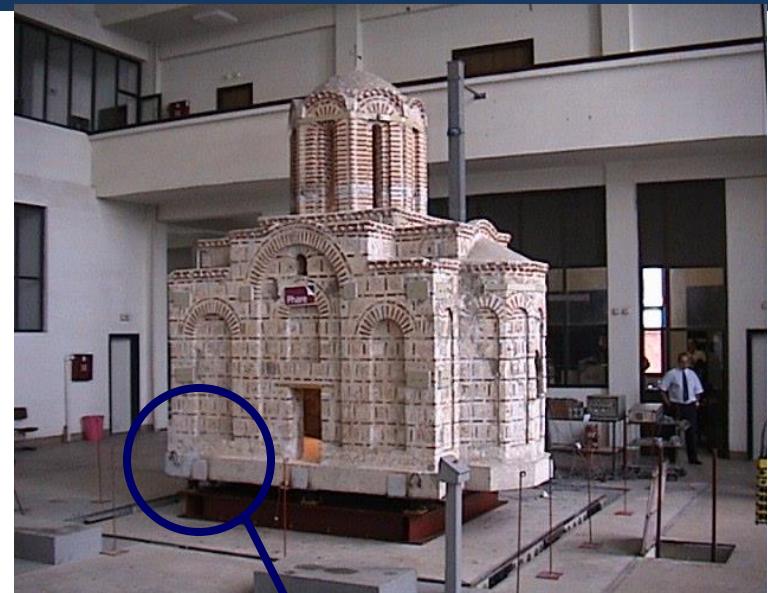
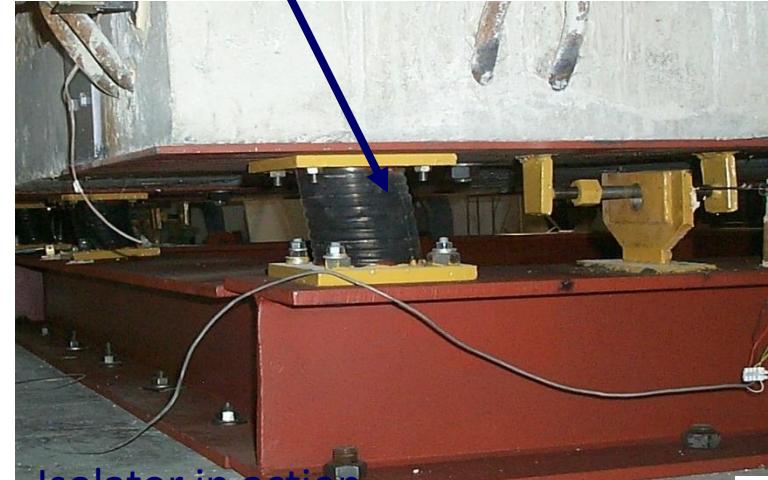
Shaking table testing of base-isolated model

Isolator in action

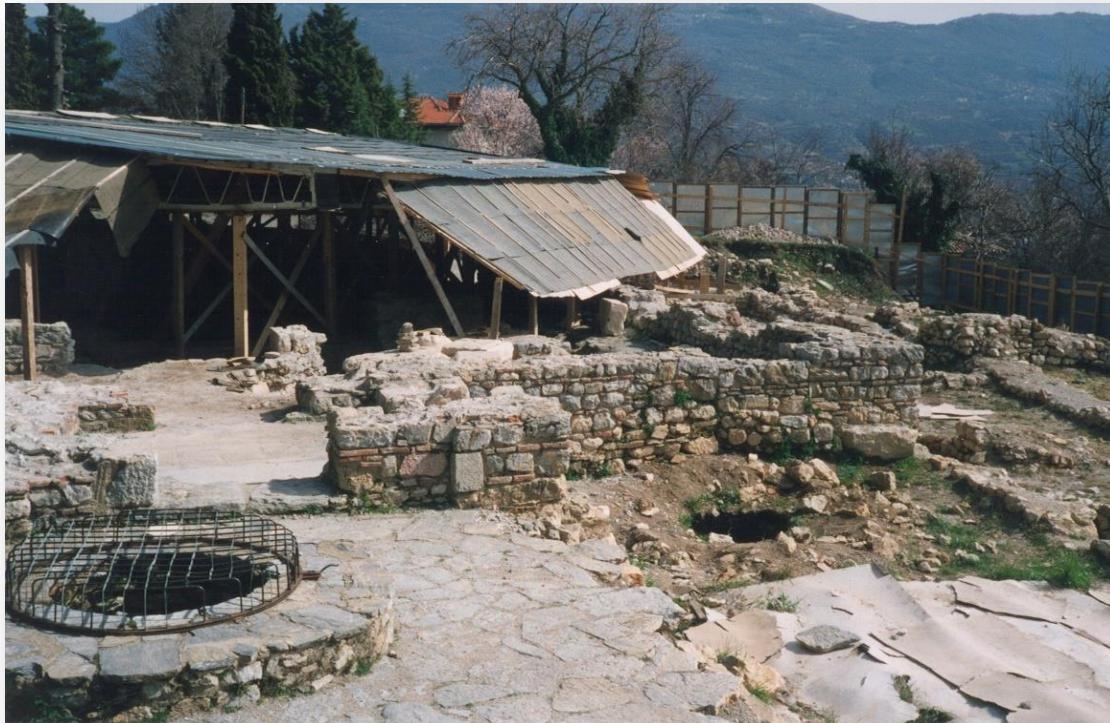
Consolidation and Reconstruction of the Structure of the St.Pantelymon Church in Plaoshnik, Ohrid

Concept for Consolidation and Rebuilding

- ✓ Injection of the walls:
 - Walls below the floor level with cement emulsion
 - Walls over the floor by use of lime-based emulsions
- ✓ Contact between the existing and the rebuilt walls
- ✓ Strengthening and the consolidation of the existing foundation walls up to level 0.00
- ✓ Reinforced concrete floor slab with a thickness of 20 cm
- ✓ Construction of the church as massive stone and brick masonry in lime mortar with incorporated **horizontal and vertical steel ties**

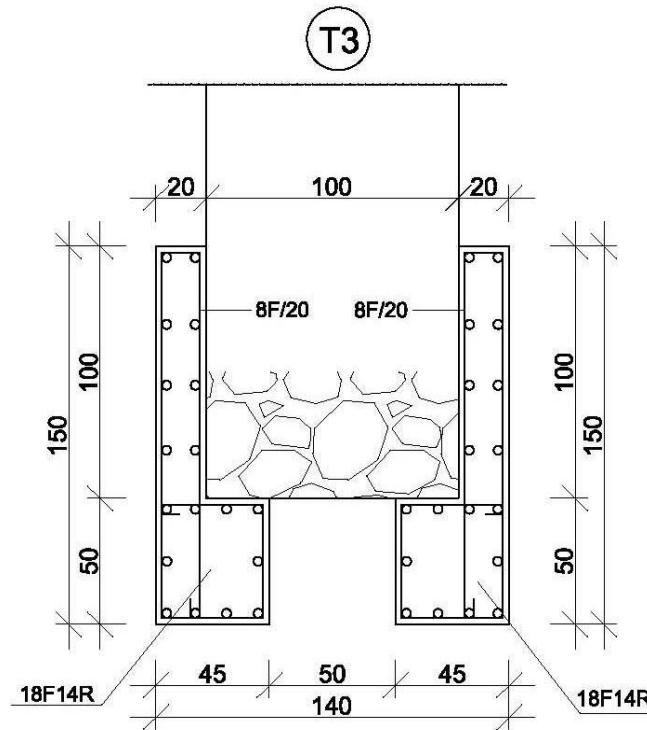
foundation

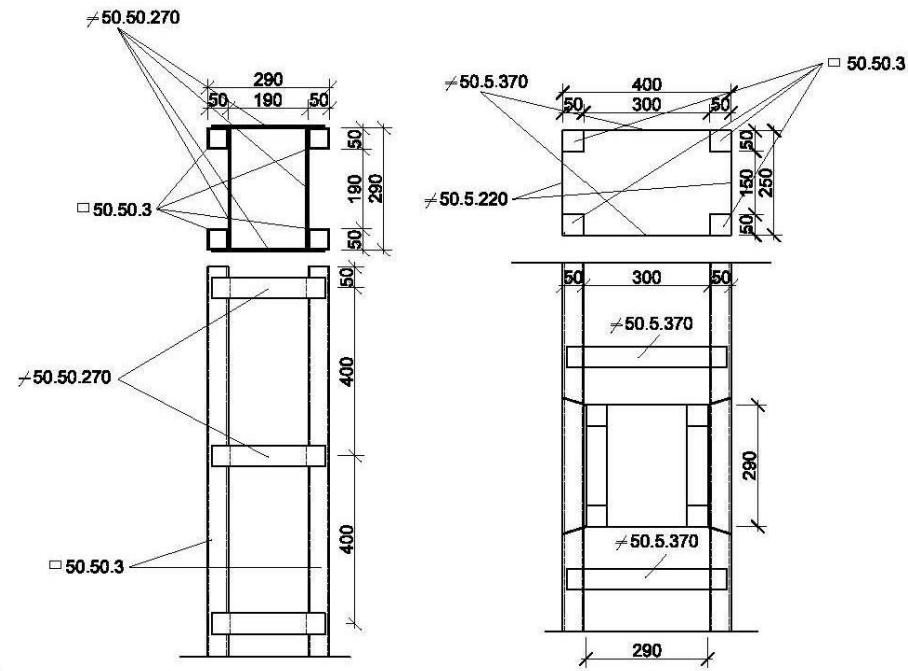
horizontal & vertical steel ties

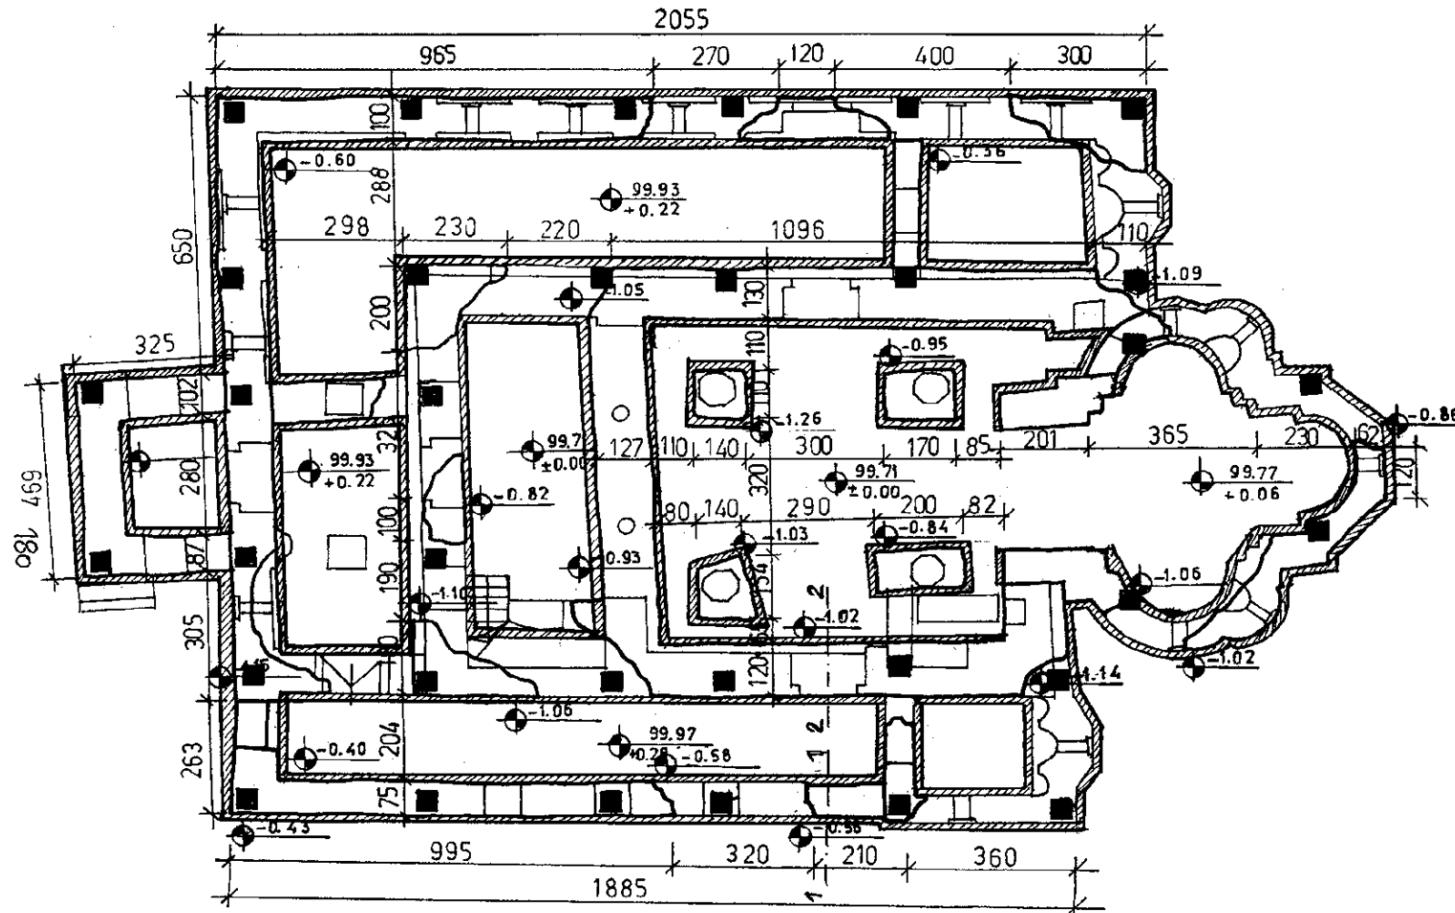
plan of the structure at the level of -0.22m

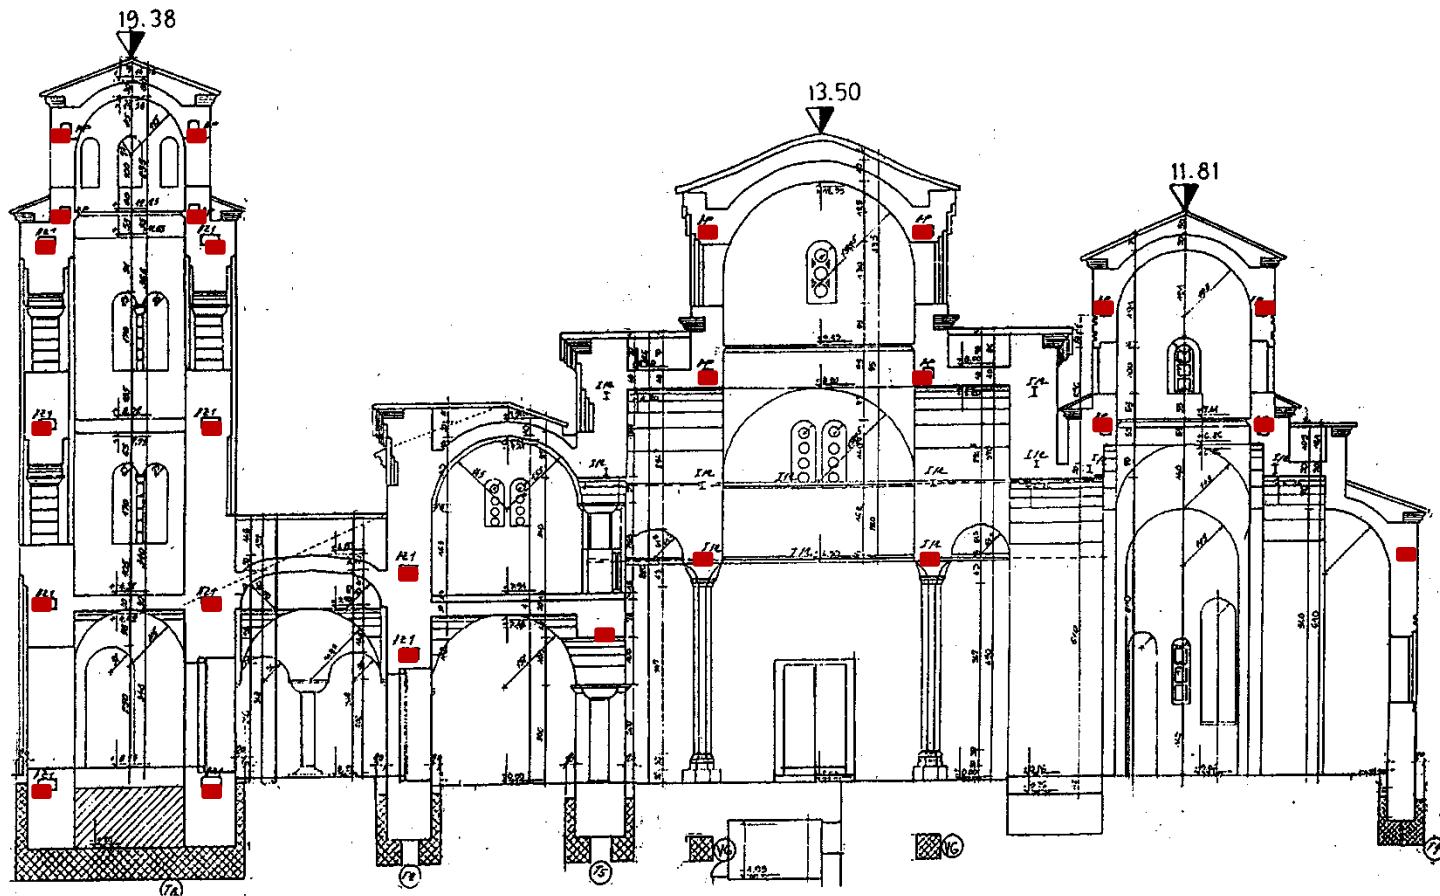
cross section of the structure

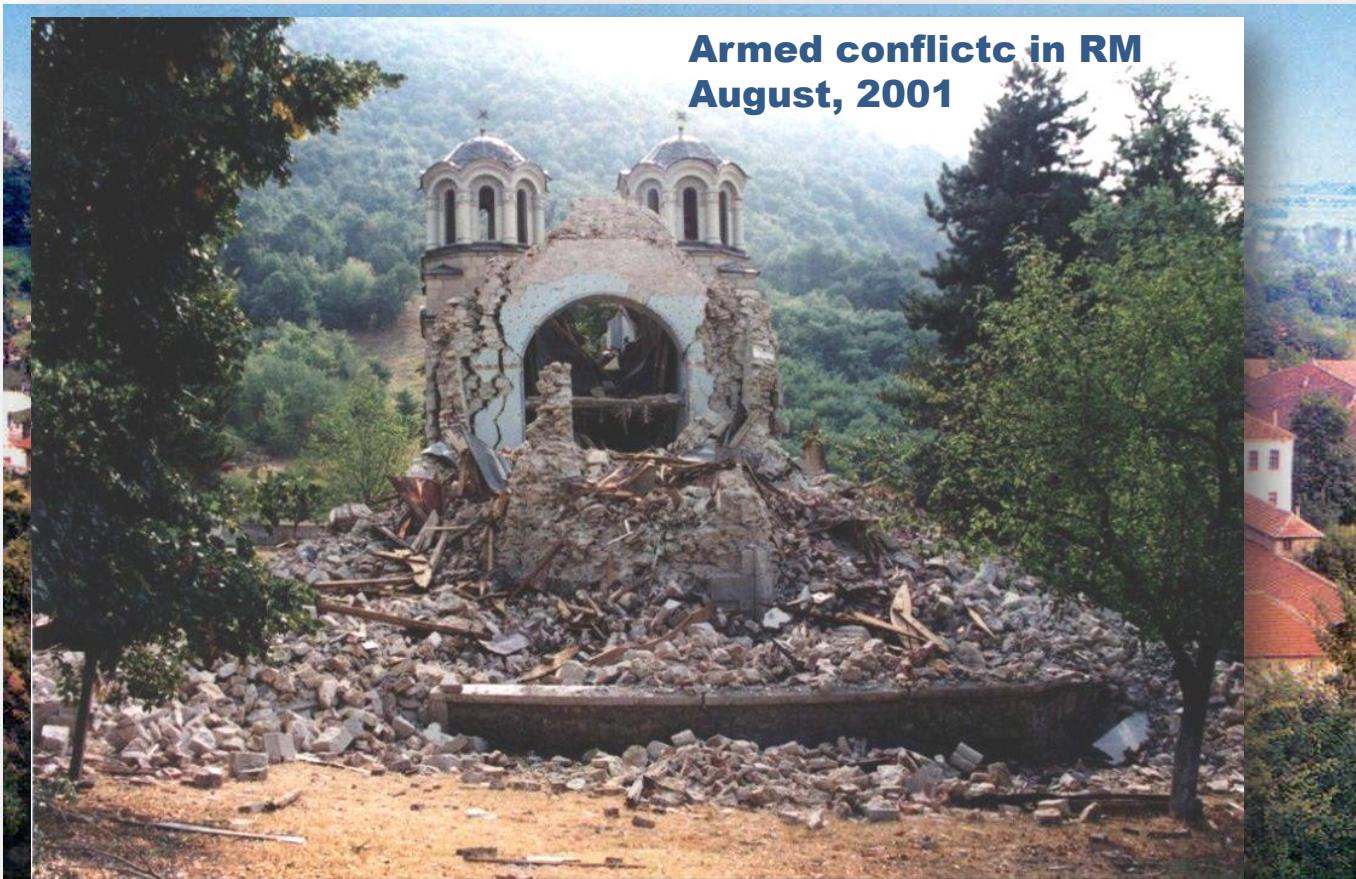
Reconstruction, Seismic Strengthening and Repair of the St. Athanasius Church in Leshok

Concept for Repair, Strengthening and Reconstruction

1. Repair and structural strengthening up to the design level of seismic safety for the *damaged existing part*
2. Complete reconstruction by maximum possible use of selected material in lime mortar plus structural strengthening elements for the design level of seismic safety for the *demolished part*
3. Dilatation (not less than 3 cm) between the structural units

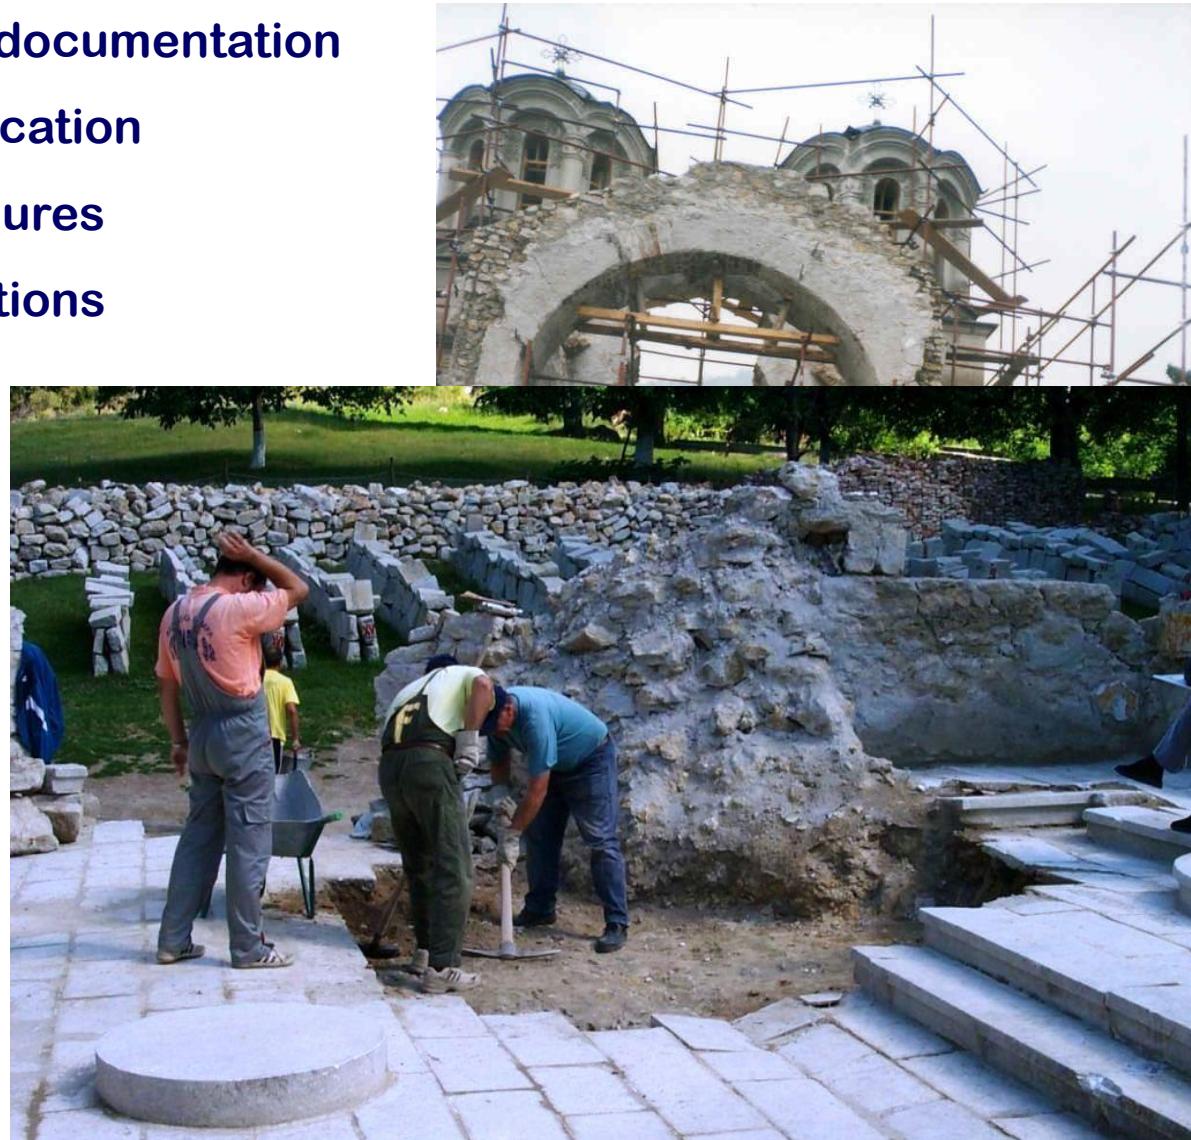
Experimental verification of Input Design Strength of Lime Mortar

- Job mix formula for lime mortar
 $M = 1$ (slaked lime) : 1 (broken half-backed brick) : 1 (sand)
- Building of wall elements
- Testing of elements under axial pressure
- Testing of elements under diagonal pressure

Wall element	Age of element (months)	Cross-section A (m^2)	Maximal force P_{max} (kN)	Compressive strength $\sigma_c = P_{max}/A$ (kPa)
W1-1	4	0.243	372	1530
W1-2	4	0.243	355	1460
W1-3	4	0.243	292	1200

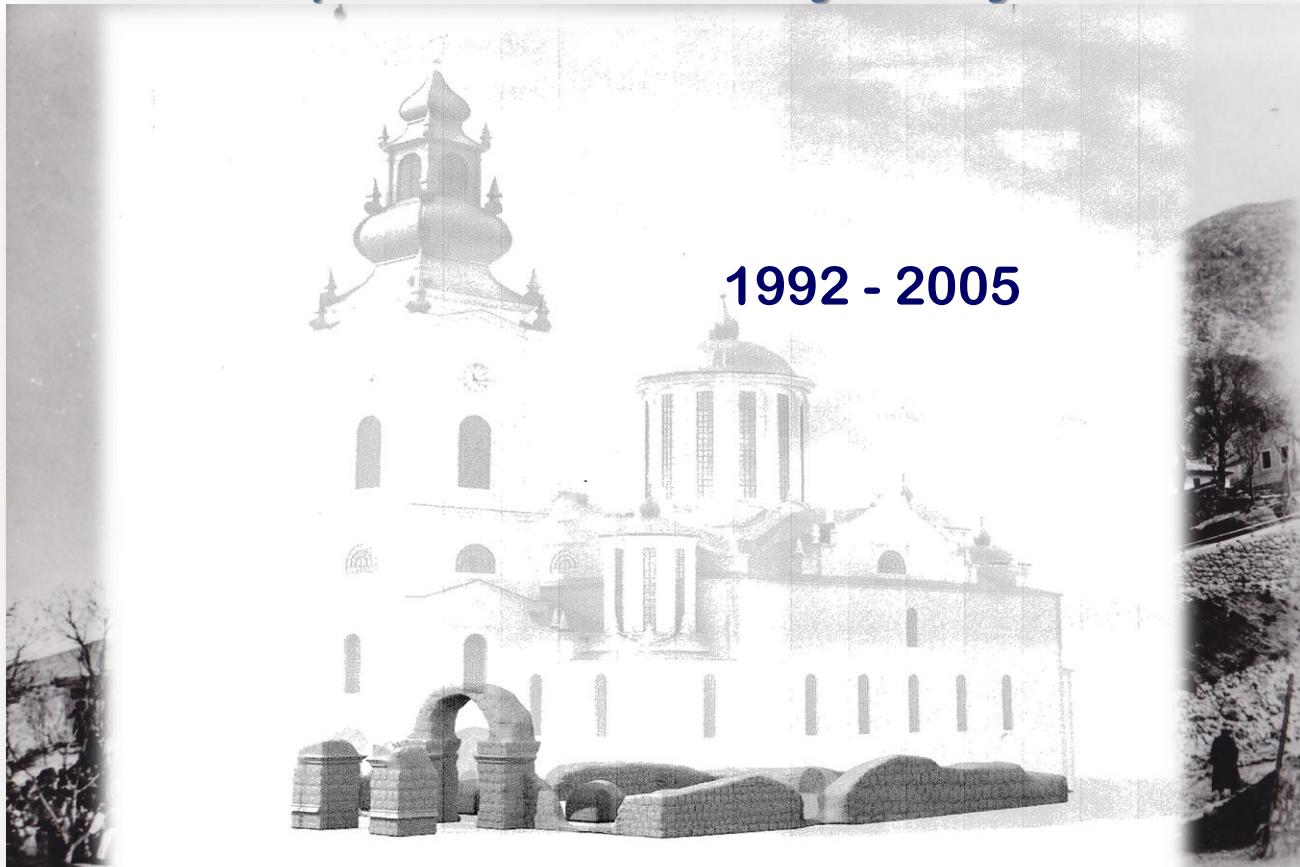
Reconstruction and Seismic Strengthening of the Blown Up Church of the Holy Trinity in Mostar

Concept for Strengthening and Reconstruction

1. Full reconstruction with maximum possible use of the existing preserved material and minimum additional intervention
2. Three general states have been analyzed:
 - (1) structural system of plain stone masonry (PS);
 - (2) strengthened structure by horizontal steel element (HS)
 - (3) strengthened structure by horizontal & vertical steel strengthening elements -confined masonry (HVS)

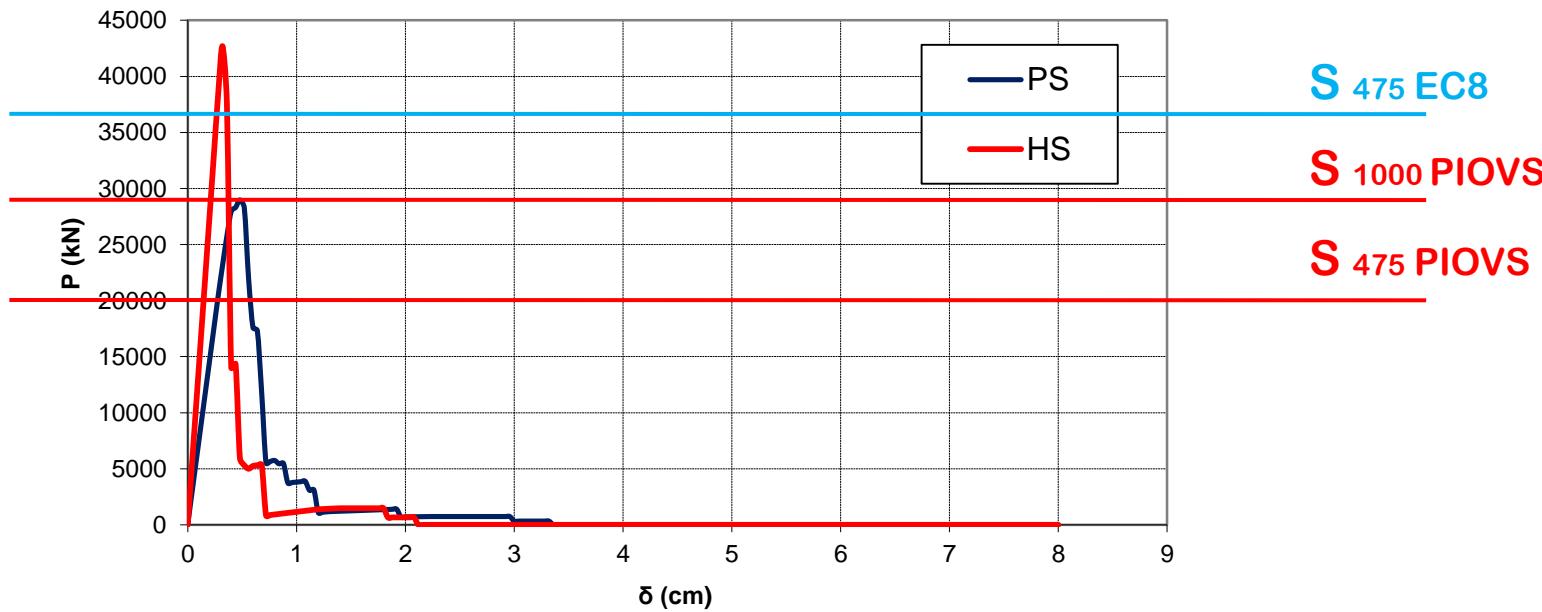
Strengthening with horizontal strengthening elements

S 1000 EC8

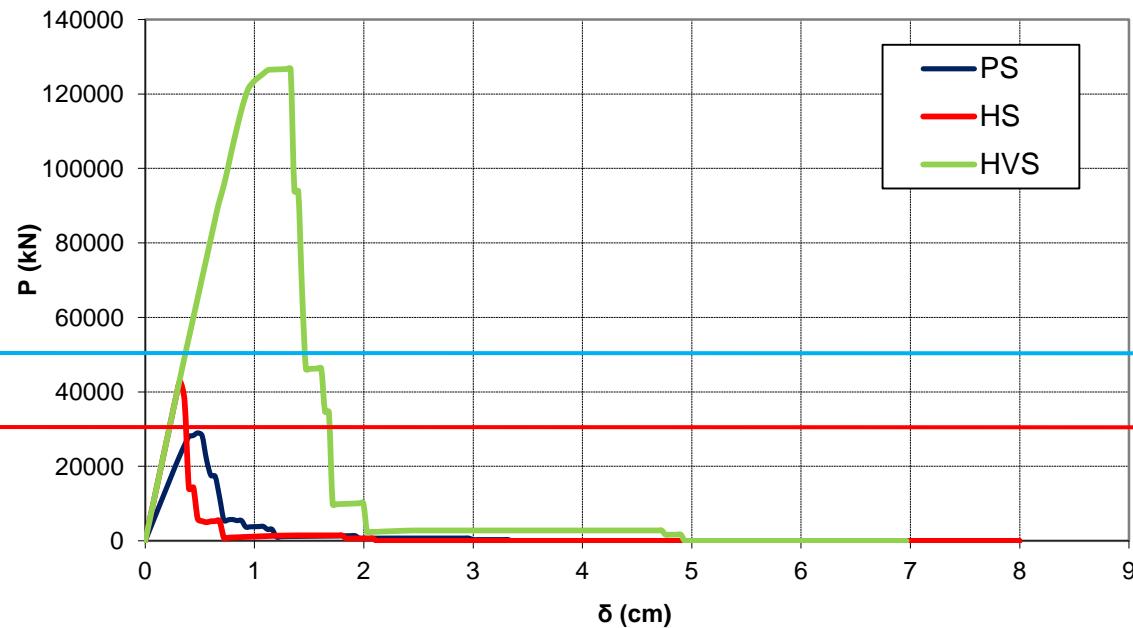
Strengthening with horizontal and vertical strengthening elements

S₁₀₀₀ EC8

S₁₀₀₀ PIOVS

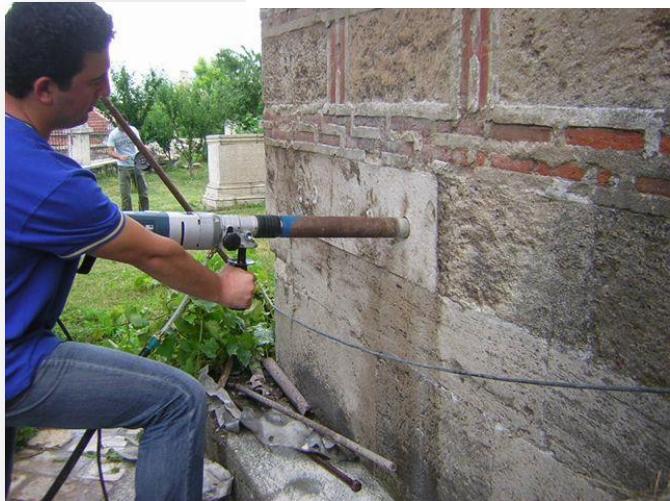
In-situ investigation

stone: $F_{\text{cube}} = 19.6 \text{ MPa}$
 $E_{\text{stone}} = 15467 \text{ MPa}$

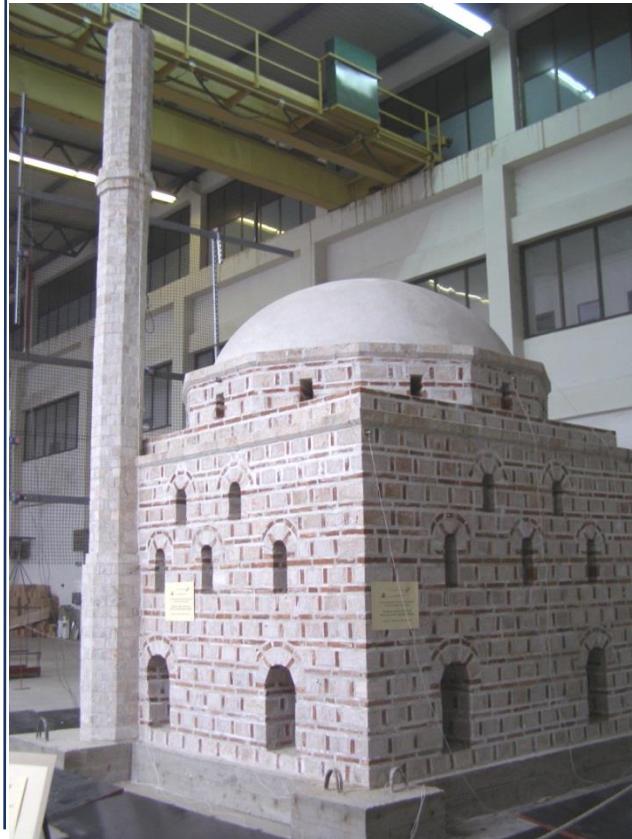
EU FP6 – PROHITECH Project (2004 – 2007)**Shaking table testing of the mosque model (2006-2007)**

**original state**

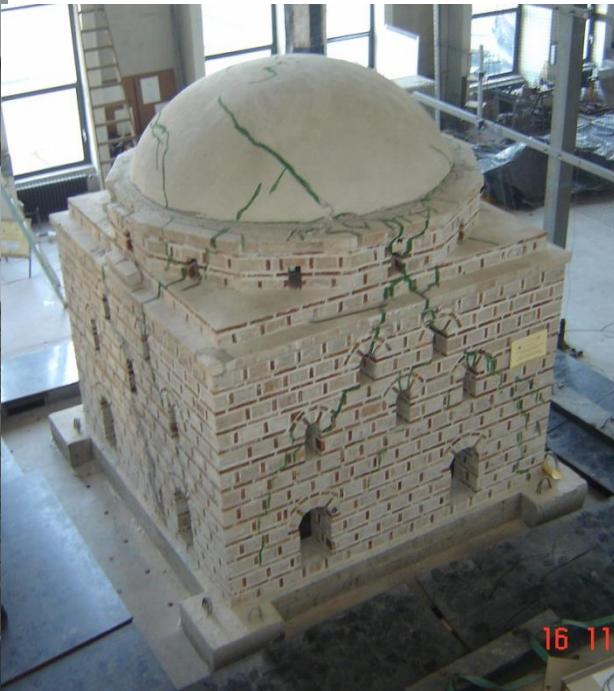
**strengthened by
CFRP bars & wrap**

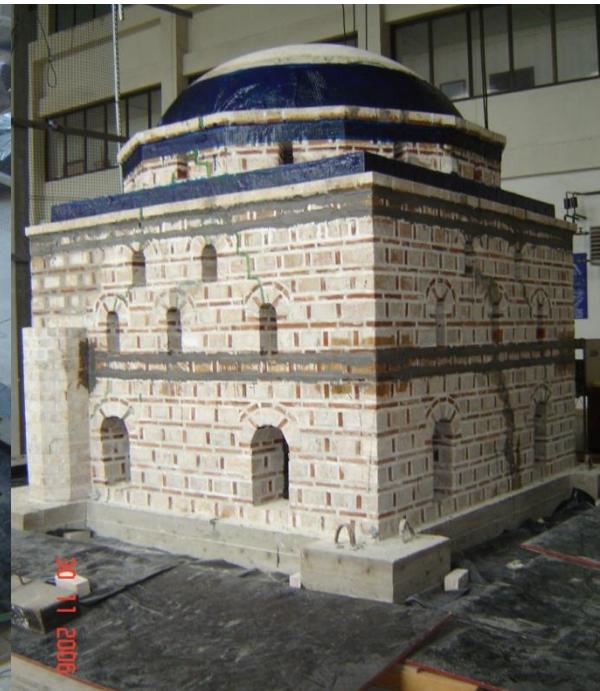
**DOME Structure (A)**

CFRP wrap in a layer of epoxy glue within a width of 2.9m

BEARING WALLS (Bents (B,C,D,E,G,H))

CFRP bars in an epoxy mortar layer

FOUNDATION (F)

RC wall on the external side, below the terrain and down to the foundation level

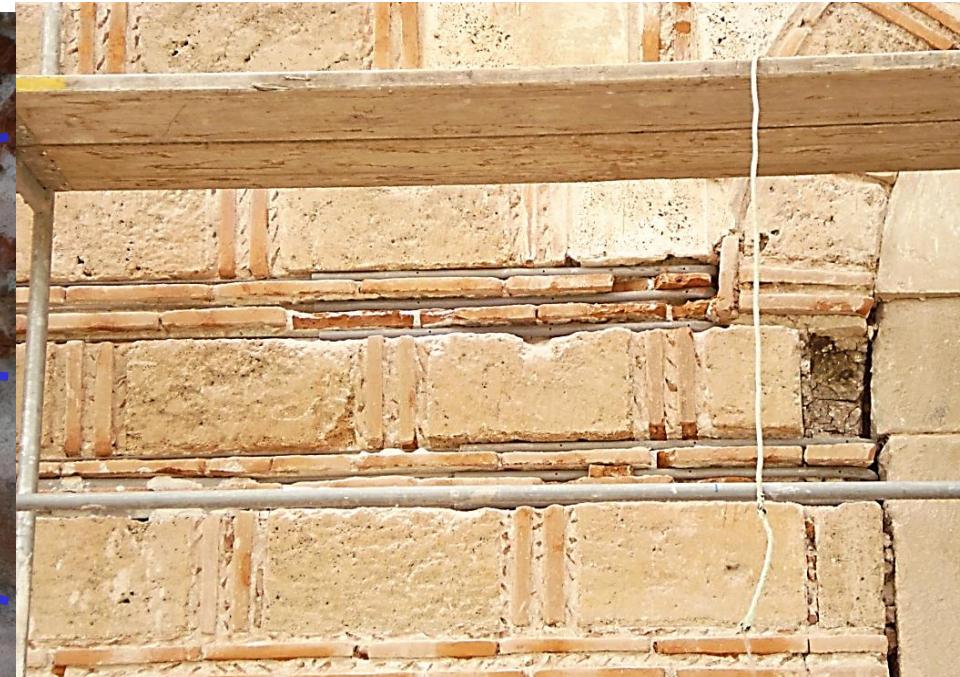
Strengthening of bearing walls

- ✓ Cleaning of all joints on the outside with a depth of max 7-8 cm
- ✓ Placement of CFRP bars ($d=1\text{cm}$) in an epoxy mortar layer
- ✓ Filling of the joints with pointing lime mortar

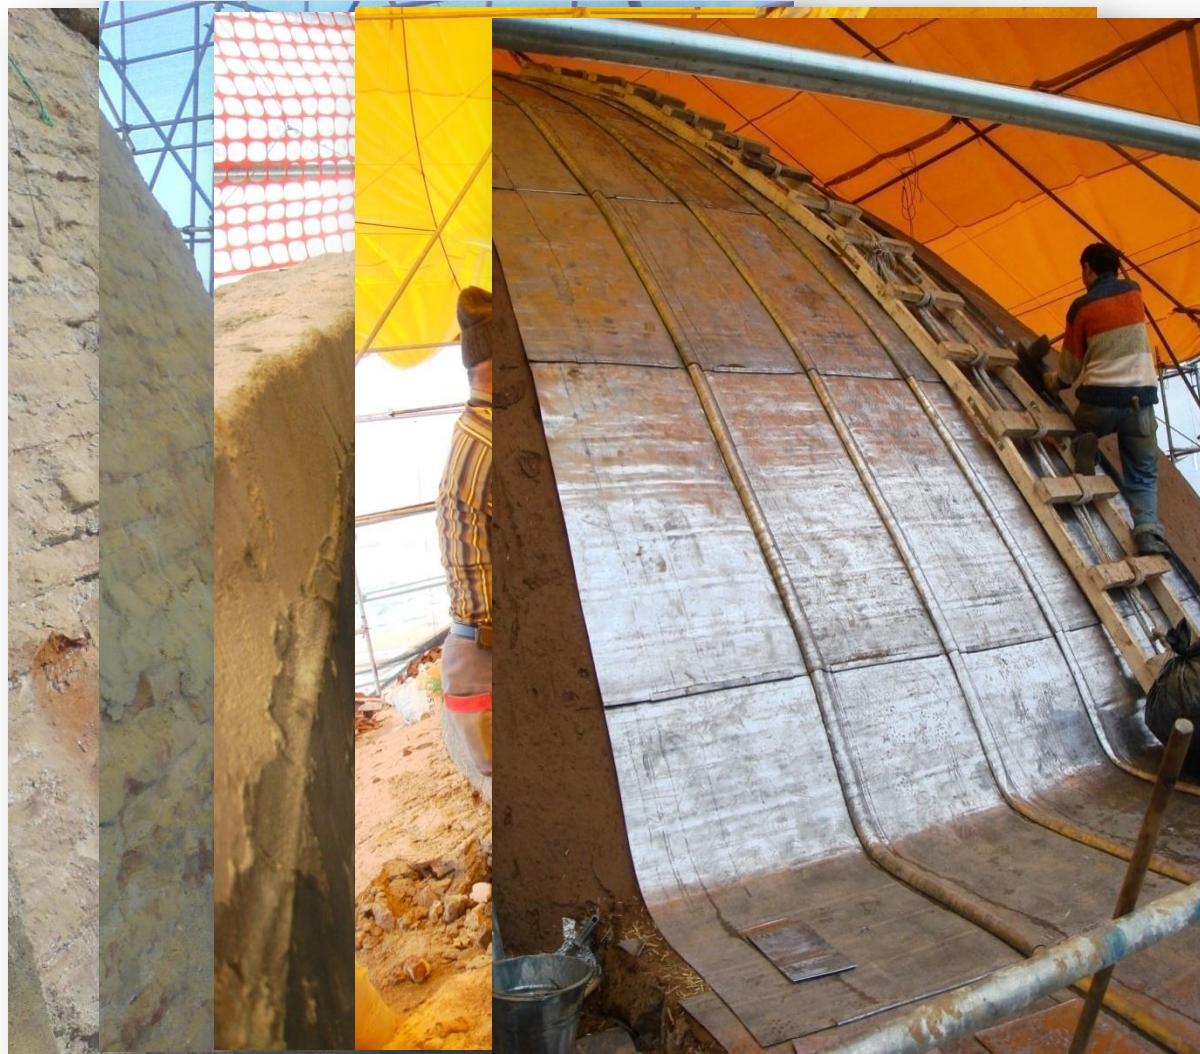
Strengthening of central dome

- ✓ Removal of the cement mortar layer
- ✓ Coating of existing RC ring with injection mixture based on lime mortar
- ✓ Placement of CFRP wrap in a layer of epoxy glue along the perimeter with the width of 3m
- ✓ Coating of entire dome with a protective layer of lime mortar

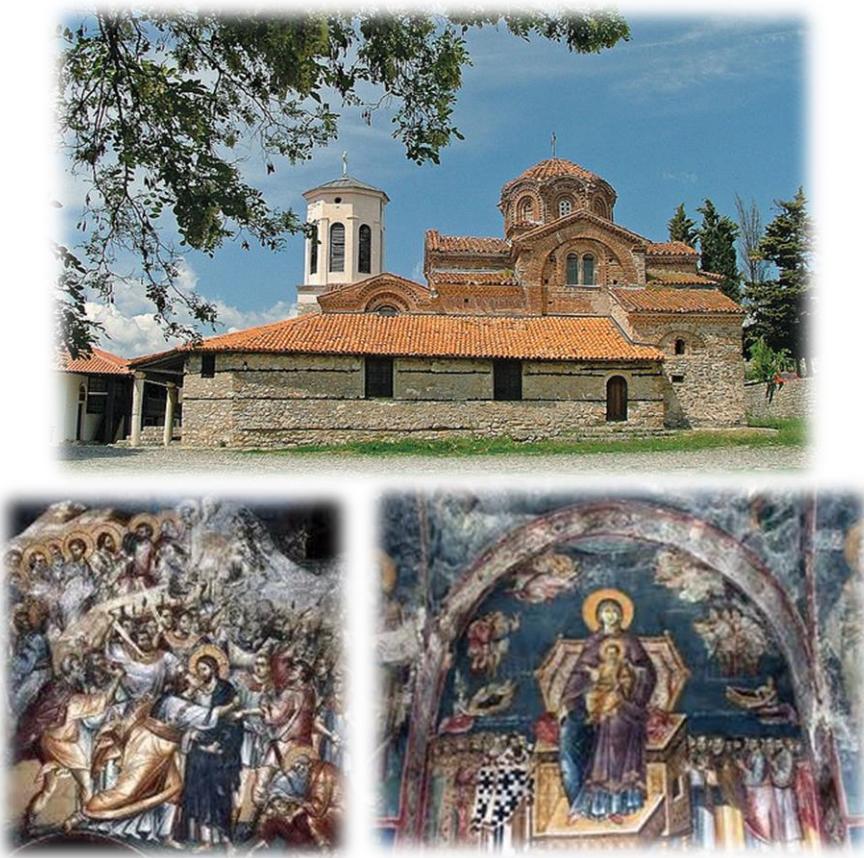
Seismic Safety and Stability of Existing Structure of St. Mary Peribleptos Church in Ohrid

- single dome, inscribed developed cross
- among most important medieval monuments
- A1, church, 1295
- small chapels, XIV c.
- A2 porch, XIX c.
- conservation 1950
- strengthening 1986

- repairing of cracks
- inserting of steel ties in central area
- placing of RC slab over the vaults
- placing of RC rings in the tambour base
- covering of the dome with cement layer

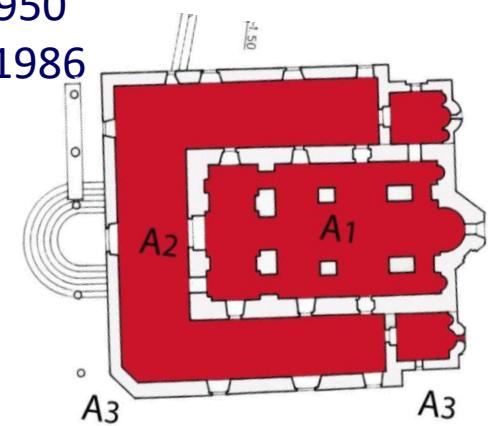
INCORRECT !

- historical respect for building authenticity
- actual capacity to prevent leaks
- due to construction errors, unsuitable materials and lack of maintenance

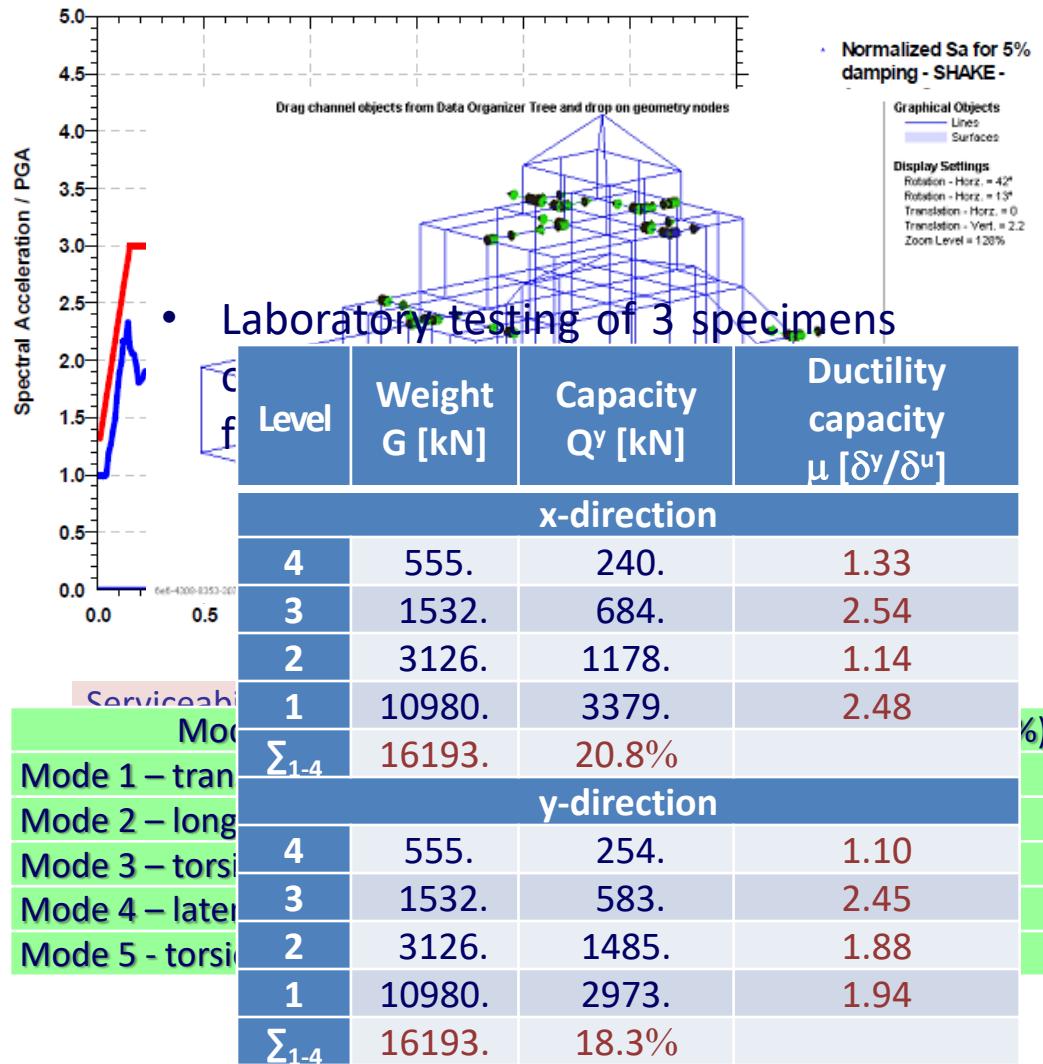
- seismic potential of site
- dynamic characteristics by AVT
- built-in material testing
- relevant structural analysis shows sufficient bearing capacity, but non-sufficient deformation capacity
