EARTHQUAKE PROTECTION OF HISTORIC BUILDINGS AND MONUMENTS IN REPUBLIC OF MACEDONIA

Dr. Veronika SHENDOVA
University Ss. Cyril and Methodius in Skopje

IZIIS' EXPERIANCE

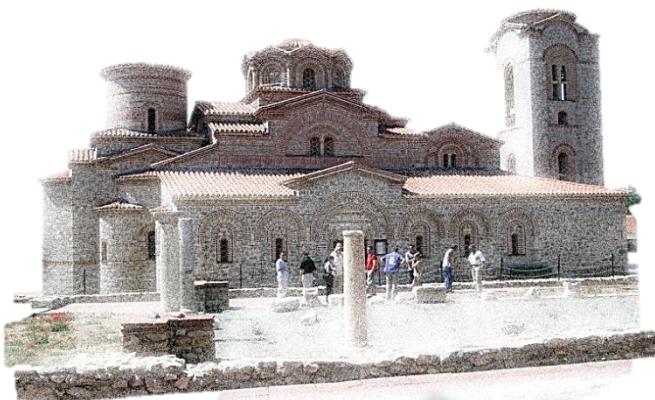
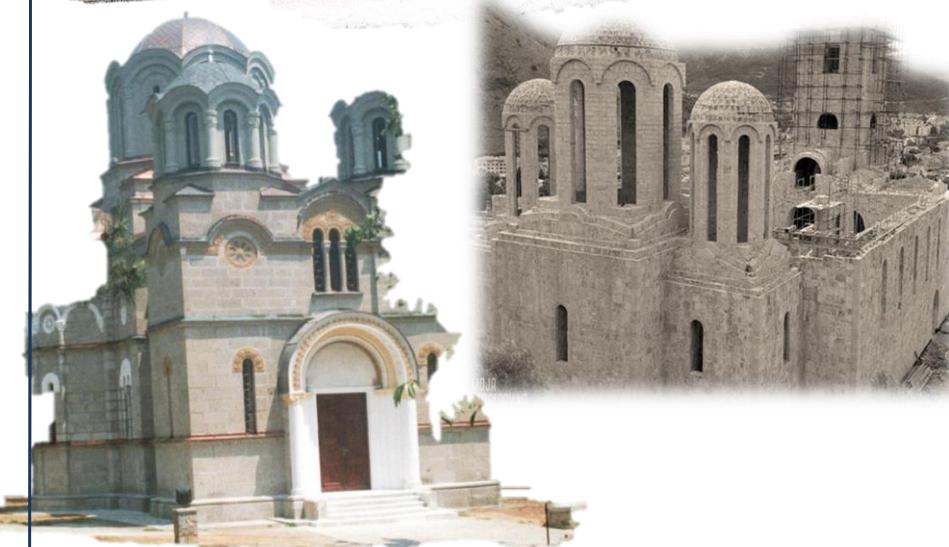
Proving the effectiveness of the selected strengthening could be successfully overcome by using “design by testing” methodology.

It is very powerful tool, especially when the object of design is a complex structure, which is difficult and unsafe to analyze by using traditional methods.
