Mirjana Malešev [1]

Vlastimir Radonjanin [2]

FIRE DAMAGES OF REINFORCED CONCRETE STRUCTURES AND REPAIR POSSIBILITIES

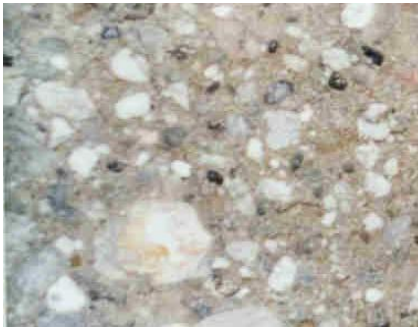
- **Sloughing off spalling**: Sloughing off is the form of progressive gradual spalling, that is caused by strength loss due to internal cracking and chemical deterioration of the cement paste.This type of spalling is non-violent breaking off of concrete fragments after longer exposure to high temperatures, when concrete loses its strength (Fig. 3 and 4).

Figure 3: Sloughing off spalling (beam)

Figure 4: Sloughing off spalling (slab)

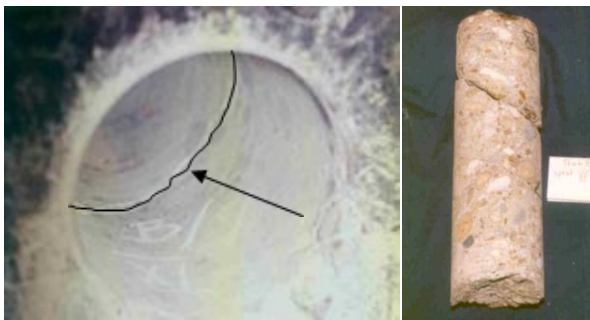
Figure 5: Post-cooling spalling

Figure 6: Crazing – mesh like cracks

Figure 7: Inner delamination of concrete in the column

Figure 8: Plastic deformations and breaking off of bars

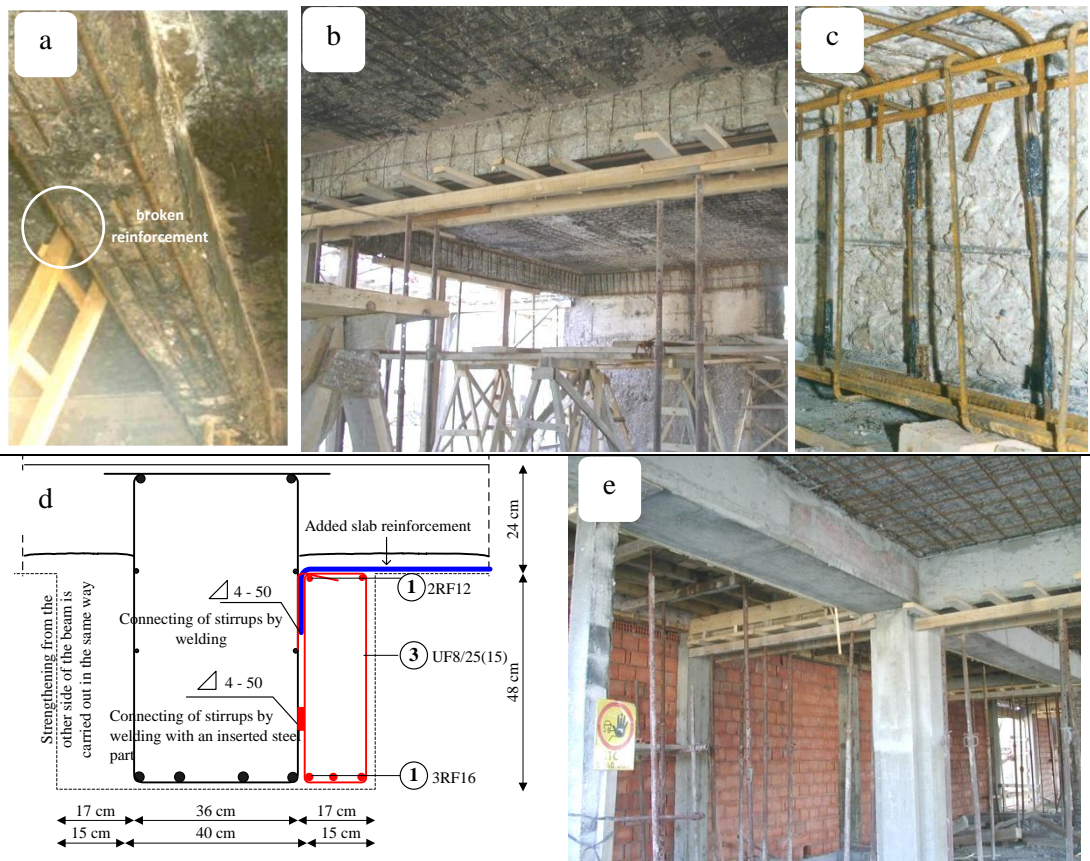
*Fig. 29: Strengthening process: **a)** View of RC beam damaged in fire **b)** Supporting of the beam and removal of damaged concrete **c)** Instalment of new reinforcement **d)** Detail of enlargement of existing cross section and arrangement of reinforcement **e)** Vie of the beam after strengthening*

Based on the recommendations for repair of fire damaged RC structures in analysed literature [6], [21], [22] and on authors professional experience [15], [16], [17] decision about general repair strategy (structural or non-structural repair) mainly depends on affected part of the cross-section and state of the reinforcement. Non-structural repair is proper choice if rebars are not or locally visible. In all other cases structural repair is required, when: reinforcement is visible, bond is destroyed, rebars have plastic deformations, structural elements have excessive deflections etc. Structural repair is also mandatory in situation when all pointed out features are not accented but inner delamination of concrete exists. In some cases main reasons for structural repair is doubt regarding remaining structural capacity and intention to provide additional structural safety during future exploitation. For easier decision about type of repair method, Table 2 could be useful. An example of structural repair solution for damaged RC beam is shown on Fig. 29.
