ASSESSMENT AND REPAIR OF RC STRUCTURE DAMAGED IN A FIRE - CASE STUDY

Abstract: The load-bearing reinforced concrete structure of the last six floors was severely damaged in the fire that occurred on the 12th floor of the 54 m tall building in Novi Sad in April 2000. This paper gives a short description of the damages to the basic structural elements and an assessment of the condition of the load-bearing structure from the 8th to the 13th floors and offers a conclusion concerning the adequate repair measures needed to obtain the load-bearing capacity and stability of the building. It also presents the details of the repair of the basic load-bearing elements of the RC structure and the rehabilitation and strengthening measures.

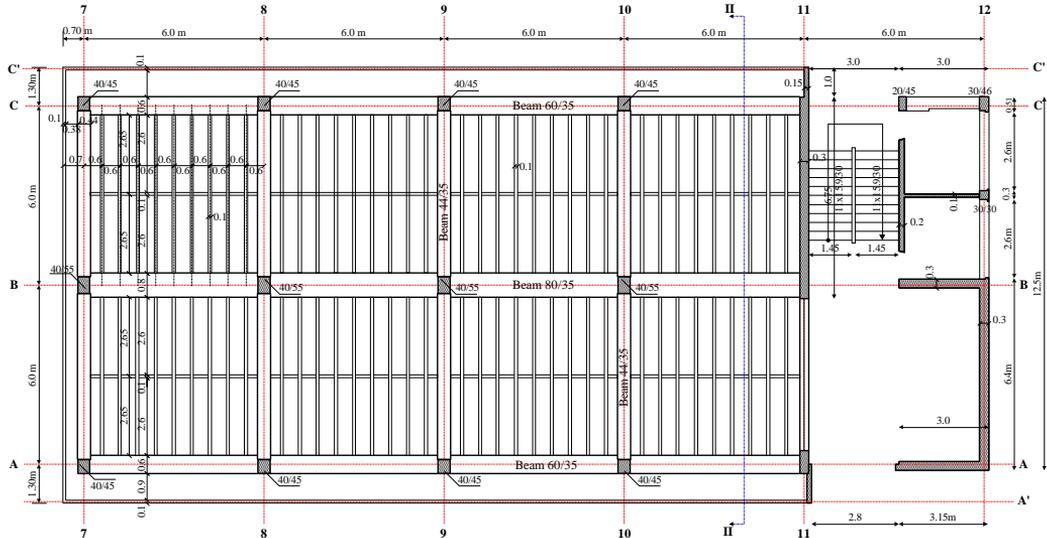
Figure 3. The plan of a standard floor

The building of the Novi Sad Open University was constructed in 1966. The building consists of the basement, ground floor, mezzanine and 13 floors. The dimensions of the basis (Fig. 3) of the building are approx. 30x15 m, and the height is 54 m. The height of the floors is as follows: basement – 2.6m, ground floor – 6.0 m, first floor – 6.0 m, floors from 2 to 13 – 3.5 m (cross-section on Fig. 4).

The structure of the building consists of a RC skeleton with an arrangement of columns at the distance of 6 m in both the longitudinal and transversal direction and RC walls in the staircase area.

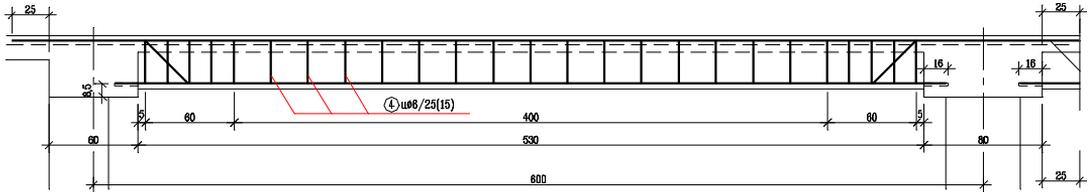
Figure 23. The new beam reinforcement plan: longitudinal cross-section

RC pan-joint structure was the most damaged element of the structure. The required repair and reinforcement of the plate floor structure with the preservation of the same construction system would demand hiring a large number of construction workers who would have to repair manually almost all the ribs and most of the slab. Therefore, the repair measures where the existing floor structure is substituted without removing it, i.e., the building of new RC beams along the 1/3 of the span and a 6cm tick slab over the existing one (Fig. 22) was chosen as a solution. Figures 23 and 24 show the transversal and typical cross-sections of the new beams with the arrangement of the reinforcement.
