# Knowledge FOR Resilient soCiEtY

*University of Tuzla*

# Repair and prevention measures of Cultural Heritage structures

## Chapel of The Virgin Mary in Lipnica

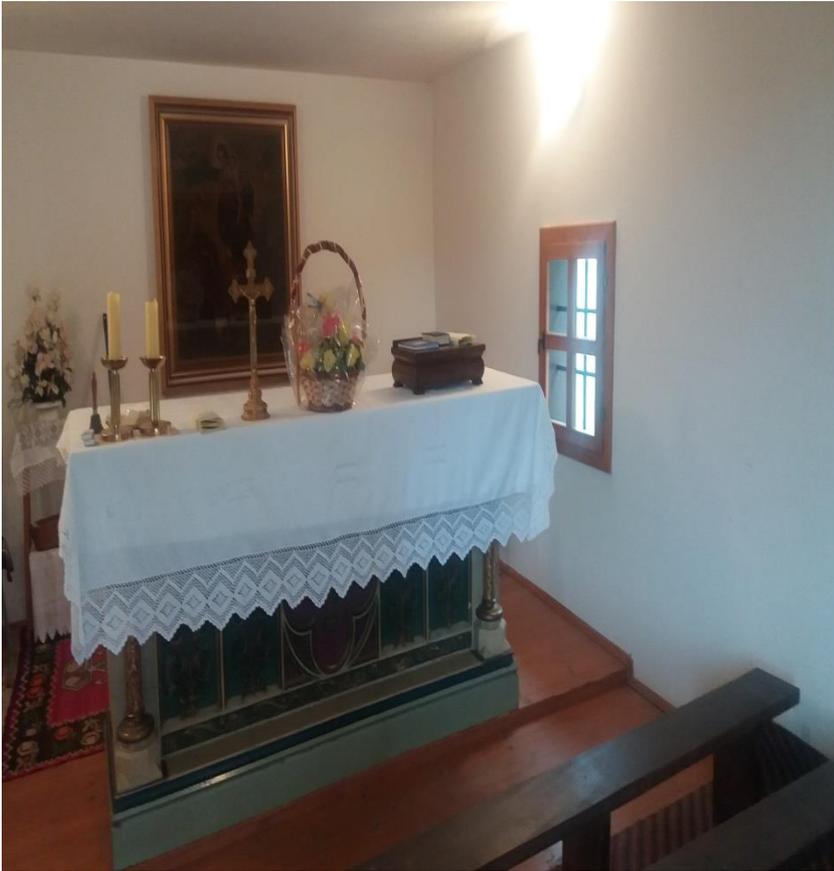
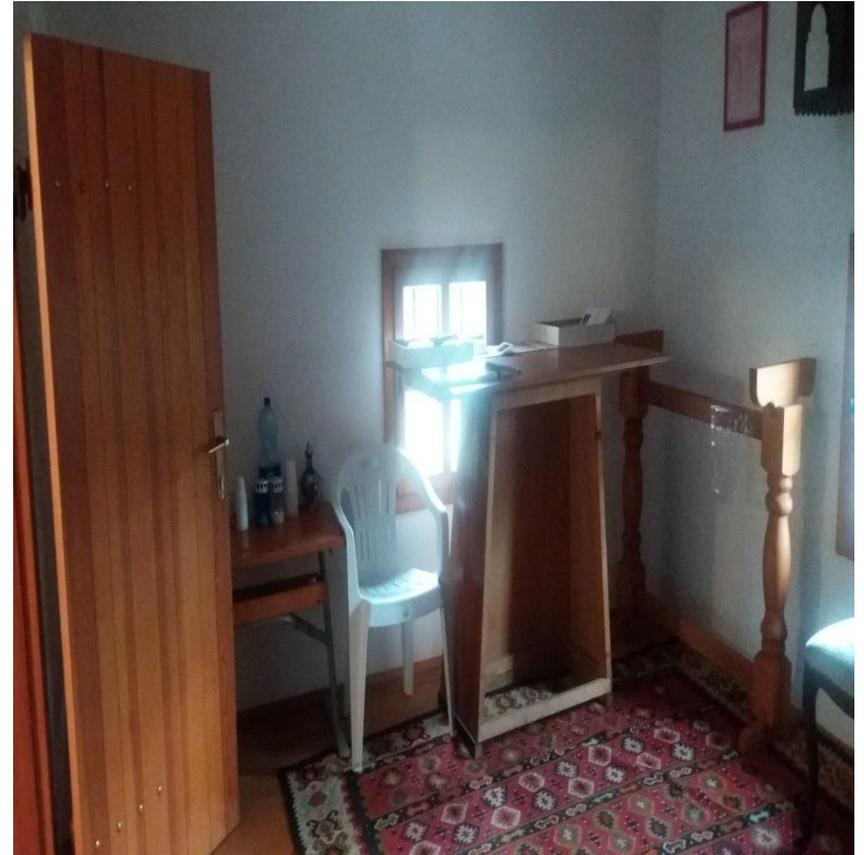
Two landslides hit this monument.

The first happened in 2001, which was repaired by supporting walls, and the second in 2014, due to weather conditions.

Landslide happened 2001 directly jeopardized monument and its construction.

Danger to the chapel was indicated by cracks on the north and west wall of the room for liturgy.
